# The Butler Trail at Lady Bird Lake

## Urban Forestry and Natural Area Management Guidelines

The Trail  
Foundation

*Produced by Siglo Group, 2015*

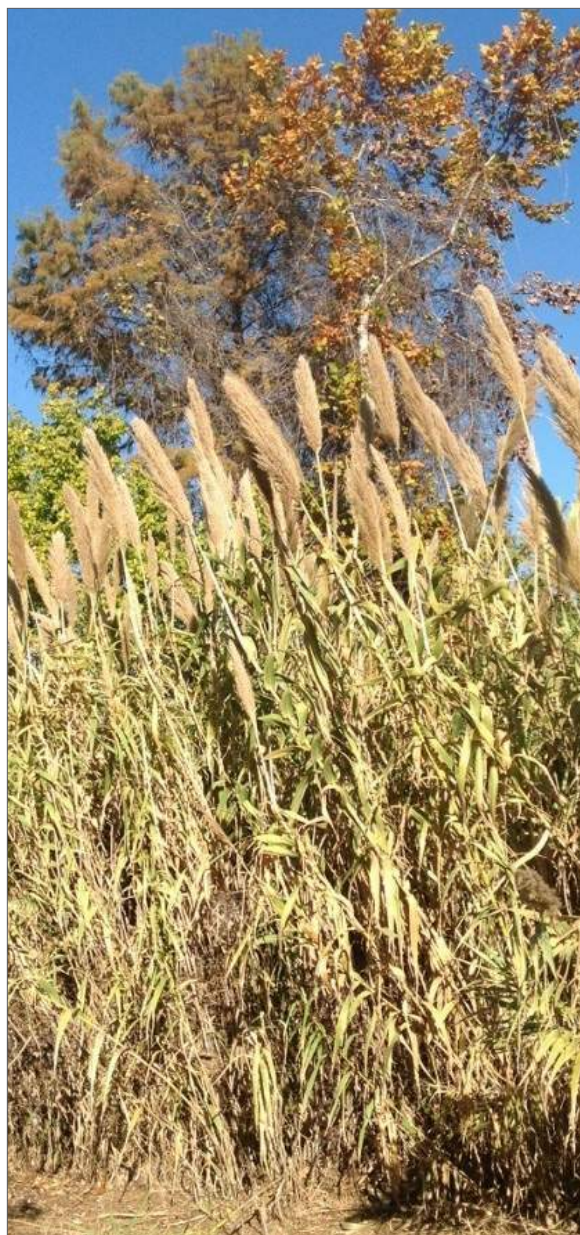
*Figure 1.7: Invasive species, like the giant reed pictured here, are one of the largest threats to the ecological health of the natural areas around Lady Bird Lake.*

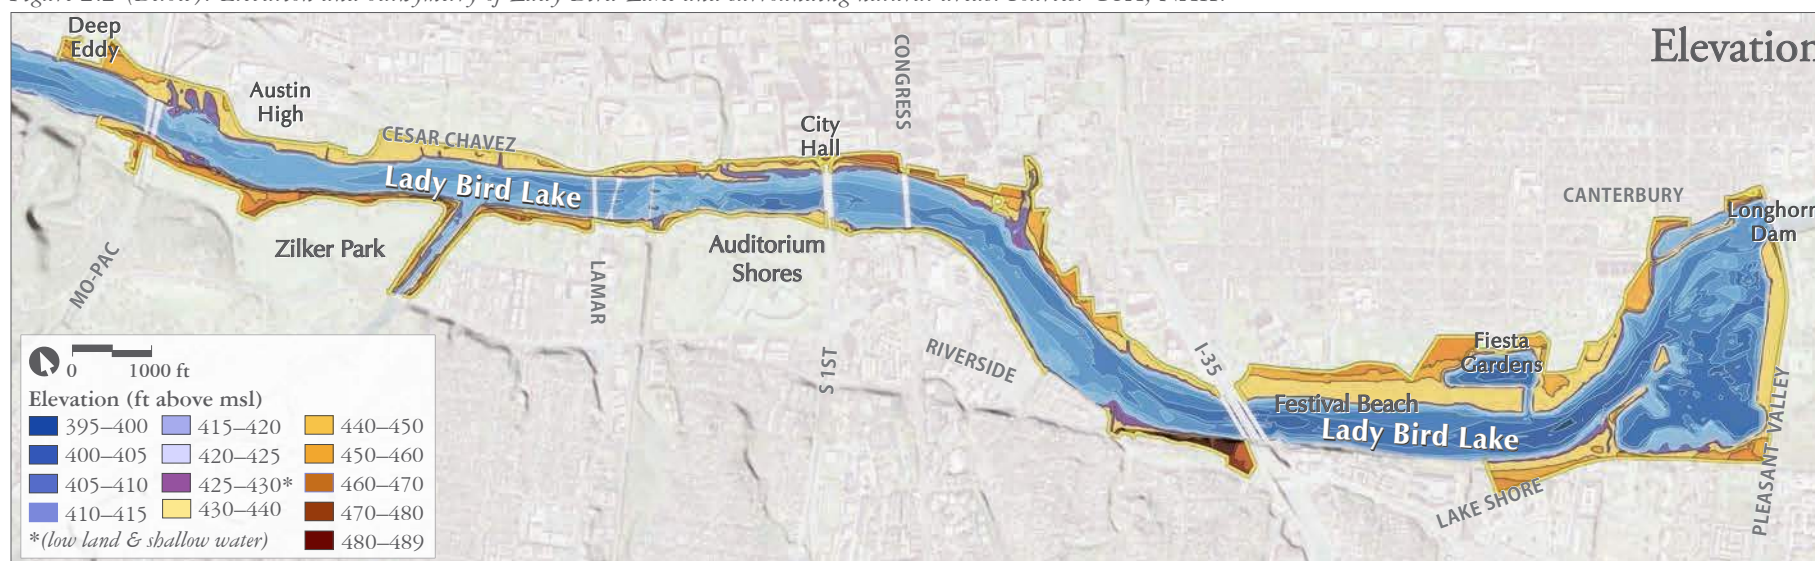
Figure 2.2 (Below): Elevation and bathymetry of Lady Bird Lake and surrounding natural areas. Sources: COA, NAIP.

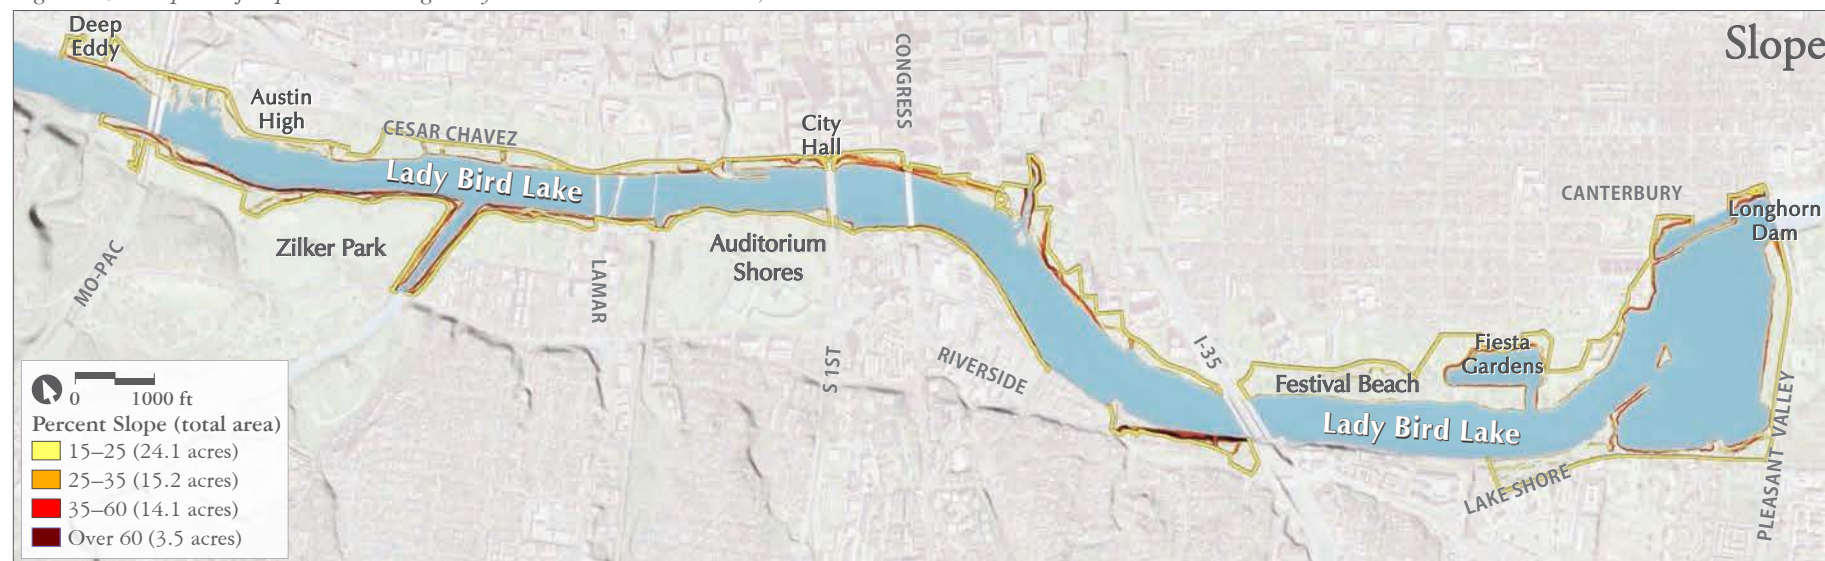
Figure 2.3: Steepness of slopes surrounding Lady Bird Lake. Sources: COA, NAIP.

429 ft above mean sea level (msl), and the lowest points of land within the study area are just above the water line. The highest point in the study area is 489 ft above msl, found on the cliffs near the Boardwalk. Changes in topography (slope) are most substantial at the cliffs on the southern shore near I-35, along the edges of Zilker Park, near the mouths of many creeks, and near the Mexican American Cultural Center. In contrast, the area near Austin High, Festival Beach, and the southeastern shore of the Lake are comparatively flat. The slopes of the site can be seen in Figure 2.3.

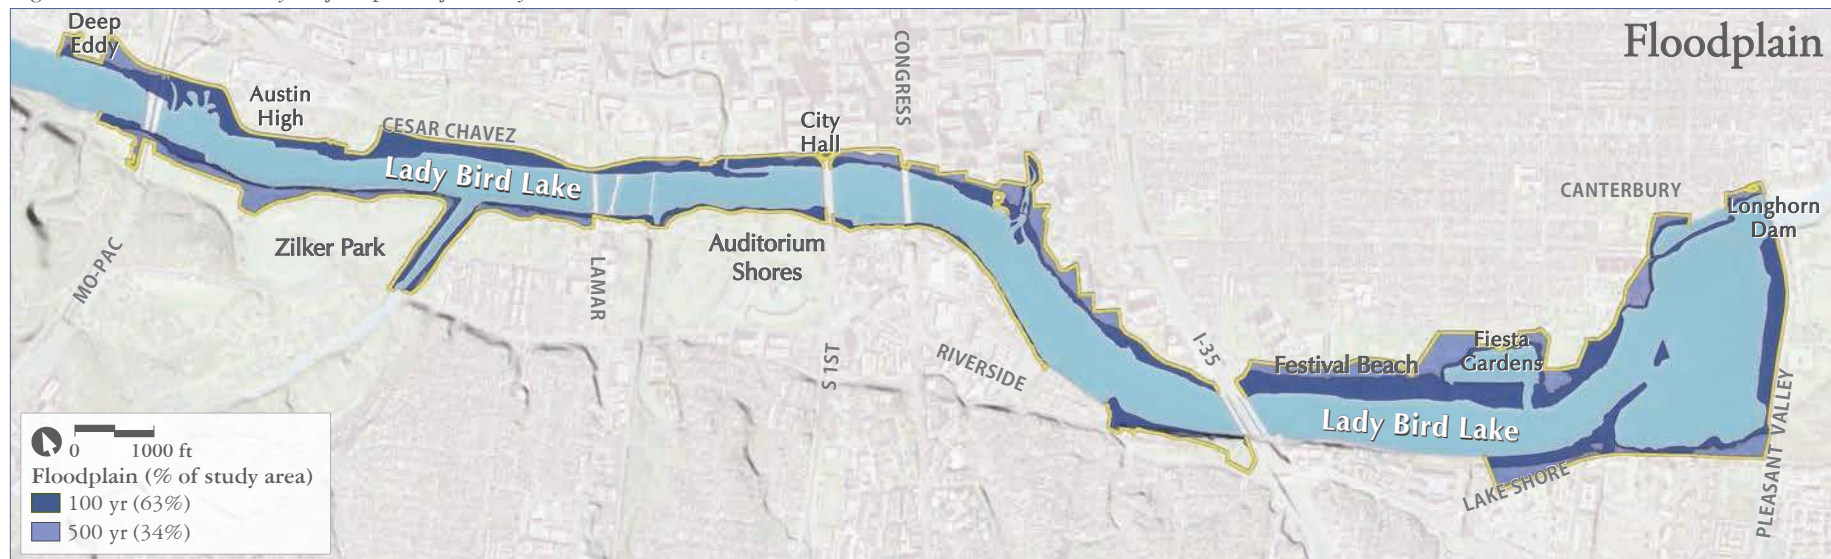
Figure 2.4: 100 and 500 year floodplains for Lady Bird Lake. Sources: COA, NAIP.

year floodplain continues to encompass 63% of the study area, and the 500 year floodplain covers an additional 34%, as seen in Figure 2.4.

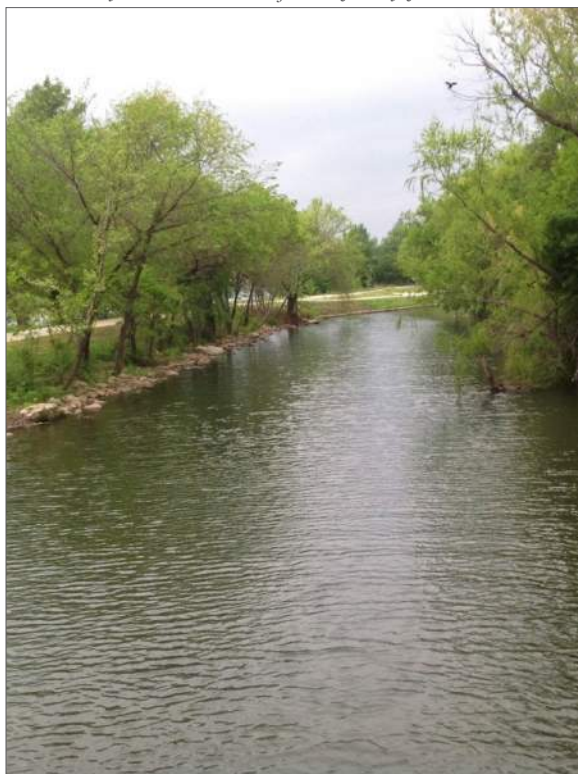
*Figure 2.5: Shoal Creek is one of the most impacted creeks in the study area and is subject to flashy flows.*

its associated high levels of impervious cover. The flashiness of Waller Creek's flows and the desire to reclaim floodplain for development have resulted in the Waller Creek Tunnel Project that is substantially altering the shoreline just west of the creek and will alter the impacts of flashy flows on the mouth of the creek. Shoal Creek does not have an equivalent project, but the problem of flashy flows and the impacts on the watershed and the mouth of the creek as it enters the study area are known (Figure 2.5). Both of these watersheds contribute substantial amounts of trash to Lady Bird Lake.

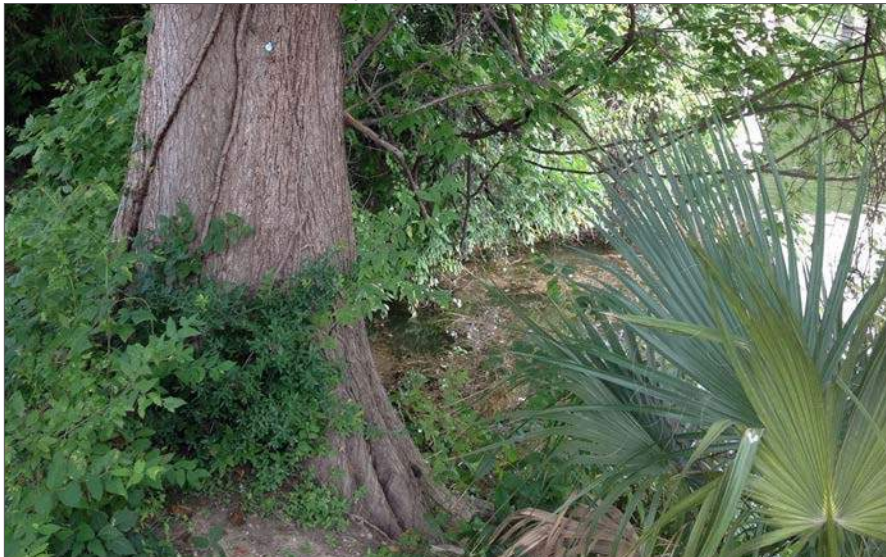
Figure 2.23: The Shoreline Woodland is characterized by large bald cypress and is generally only one tree wide, as seen here just east of 1st Street on the south shore

The Shoreline Woodland is highly influenced by the saturation of the soil. It is characterized by bald cypress (*Taxodium distichum*) along the shoreline of the Lake, as shown in Figure 2.23. In most places this community is a very narrow band, often only a few feet wide, directly along the shore. In a few areas where low-lying land extends farther from the shoreline, the Shoreline Woodland is more expansive. Other characteristic trees in this community are black willow (*Salix nigra*), green ash (*Fraxinus pennsylvanica*), Chinese tallow (*Triadica sebifera*), and eastern sycamore (*Platanus occidentalis*). Buttonbush (*Cephalanthus occidentalis*) and roughleaf dogwood (*Cornus drummondii*) are the most consistent components of the sparse shrub layer. The herbaceous layer is generally lacking diversity, composed almost entirely of Emory sedge (*Carex emoryi*), false nettle (*Boehmeria cylindrica*) and elephant ear (*Colocasia esculenta*). The herbaceous layer is more diverse in areas with flatter banks. Such areas are, however, quite un-

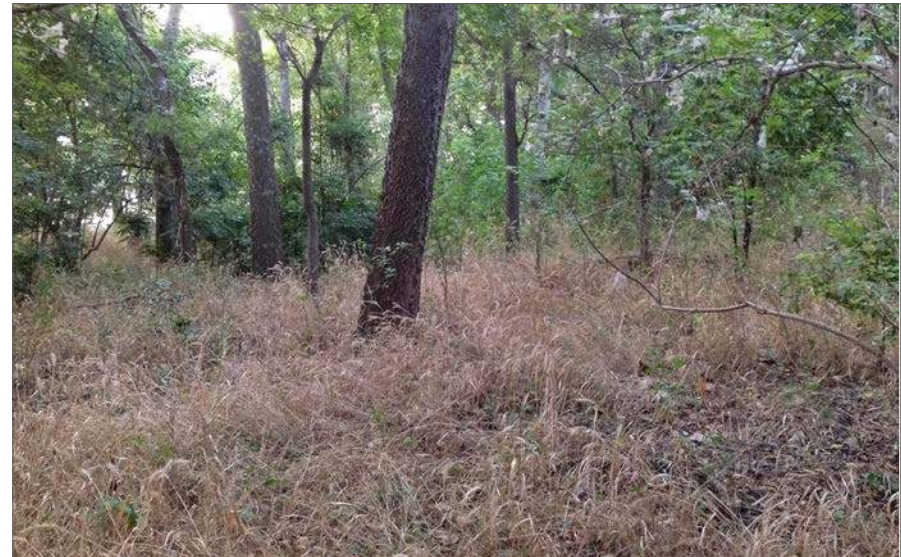
Figure 2.24: Sugar hackberry is the most abundant tree in the Floodplain Terrace Woodland, and the community often lacks a dense shrub layer, as seen here just west of MoPac on the south shore.

The Floodplain Terrace Woodland is found immediately upslope from the Shoreline Woodland. Characteristic trees of this community include sugar hackberry (*Celtis laevigata*), American elm (*Ulmus americana*), pecan (*Carya illinoensis*), cedar elm (*Ulmus crassifolia*), white mulberry (*Morus alba*), and Chinaberry (*Melia azedarach*) (Figure 2.24). Shrubs are often sparse, though some areas have dense cover of young cherry laurel (*Prunus caroliniana*). Mexican sabal palm (*Sabal mexicana*) has recently become naturalized in the study area and is locally common on the lower parts of Floodplain Terrace Woodlands. Texas persimmon (*Diospyros texana*), and Ashe juniper (*Juniperus ashei*) occur in small numbers in steep areas. Vines are often abundant in the understory. Poison ivy (*Toxicodendron radicans*) is abundant throughout and is often joined by mustang grape (*Vitis mustangensis*) and peppervine (*Ampelopsis arborea*). The ground layer is sparse in the fall (the time of the botanical survey), with characteristic species including inland sea oats (*Chasmanthium latifolium*), Virginia wildrye (*Elymus virginicus*), Turk's cap (*Malva-*

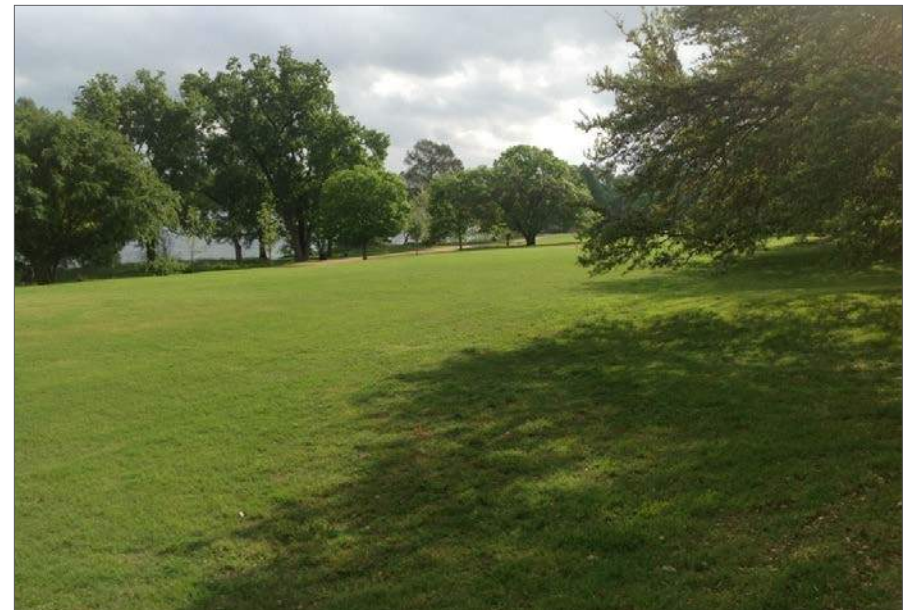
Figure 2.25: Much of the study area is mowed lawn punctuated by shade trees, like this section of the Southeast Shore near the eastern extent of the Boardwalk.

The third major plant community, Lawn, begins at the point where the slope becomes flat enough to mow (Figure 2.25). With the exception of the Johnson Creek area, the wildflower meadow areas near Cesar Chavez, and the recently instituted Grow Zone areas discussed below, the majority of the land in the study area that is flat enough to mow is frequently mowed. In the majority of lawn areas, Bermudagrass (*Cynodon dactylon*) is the dominant lawn grass. Other herbaceous plants are either absent or difficult to identify due to mowing. Exceptions occur along the very edge of the woodland, where mowers do not reach the stems of a few species such as giant ragweed (*Ambrosia trifida*), the most conspicuous herbaceous plant along edges and in Grow Zones during the fall of 2014. Many of the lawn areas have shade trees, most often pecan (*Carya illinoensis*) and live

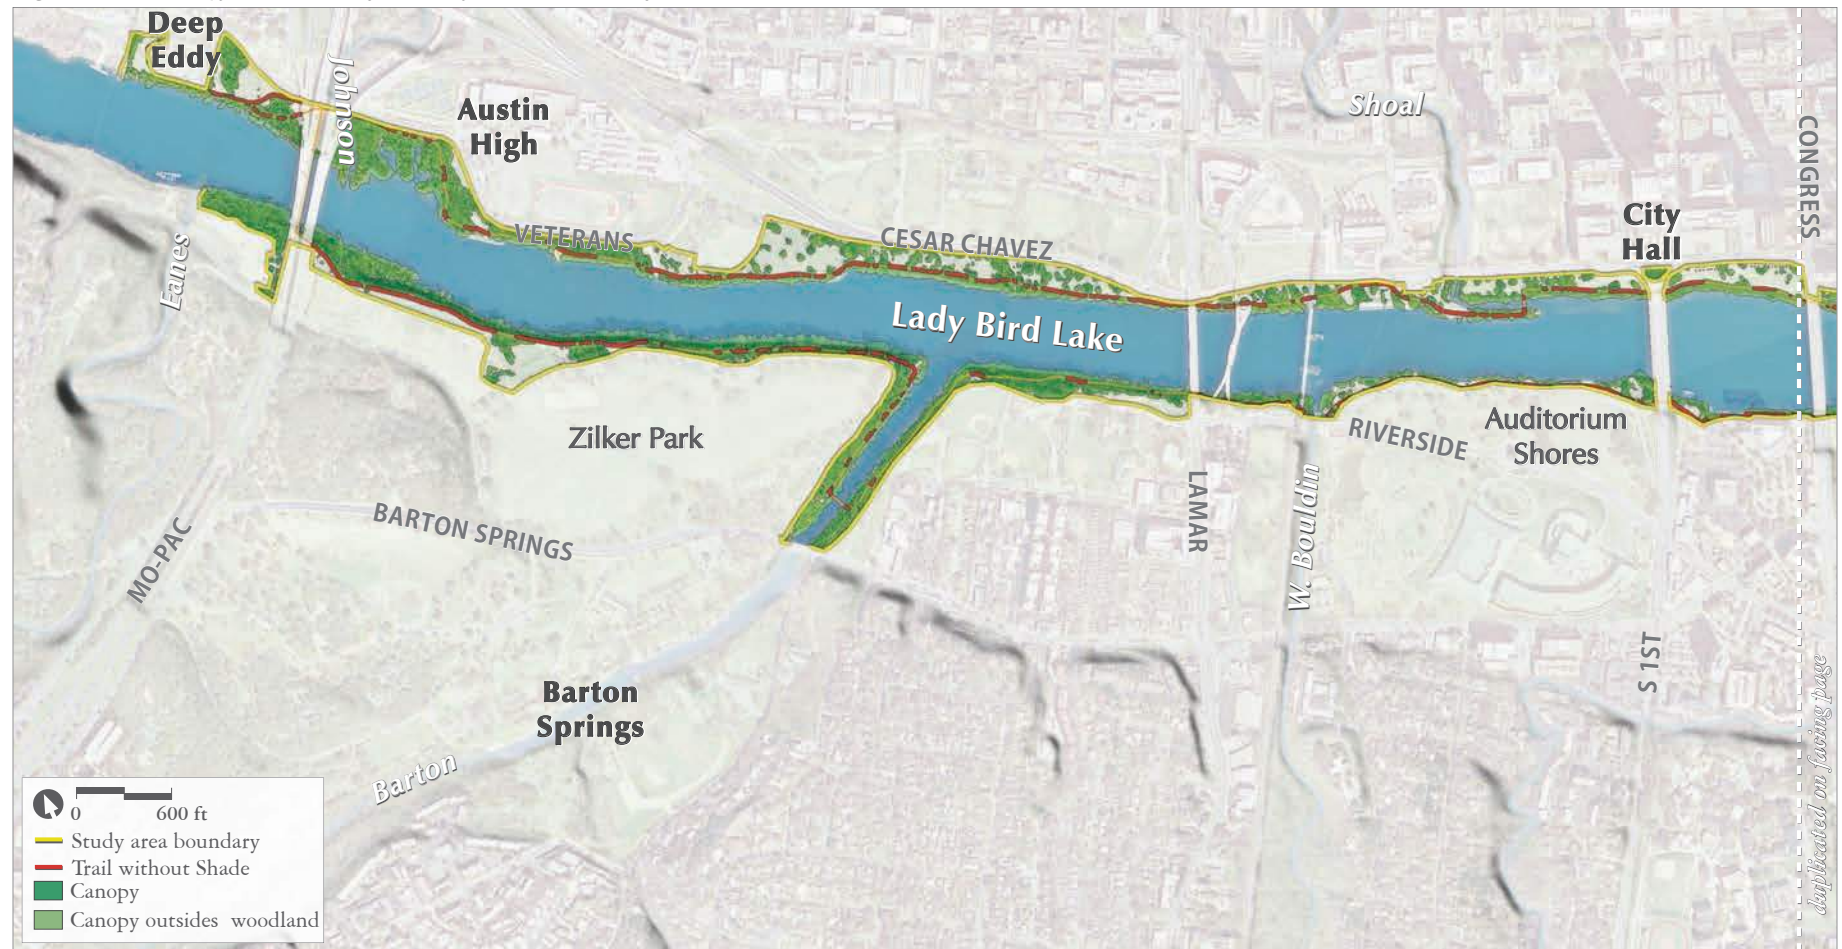
Figure 2.28: Canopy covers 49% of the study area and 48% of the Trail is in shade. Sources: COA, NAIP.

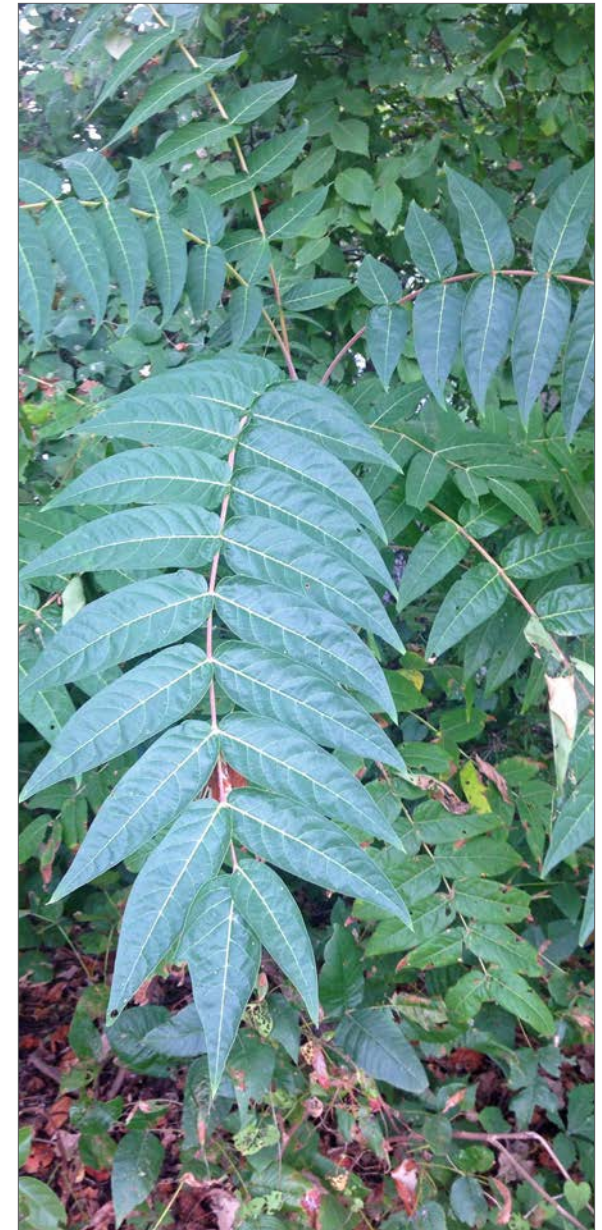
Figure 2.32: Tree of heaven is found in only a few locations in the study area but is capable of forming dense stands.

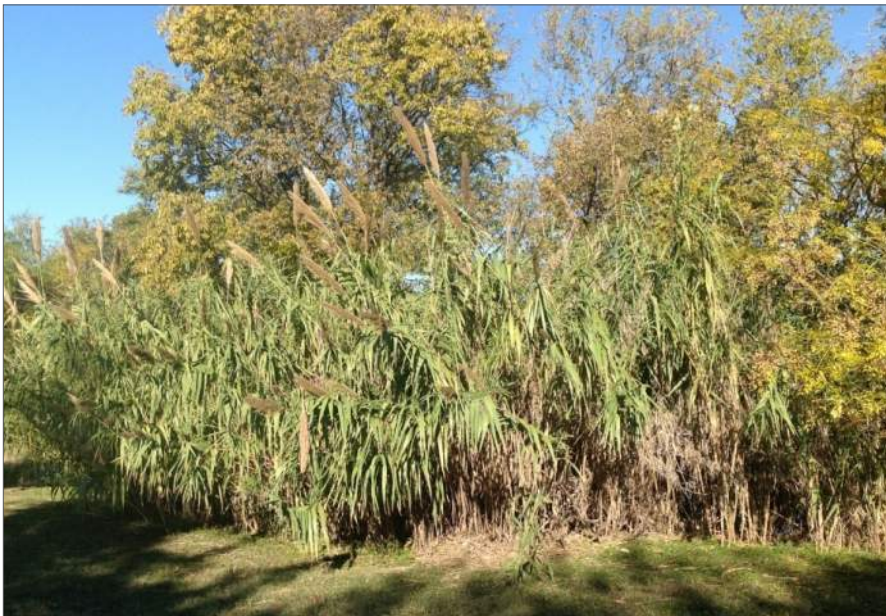
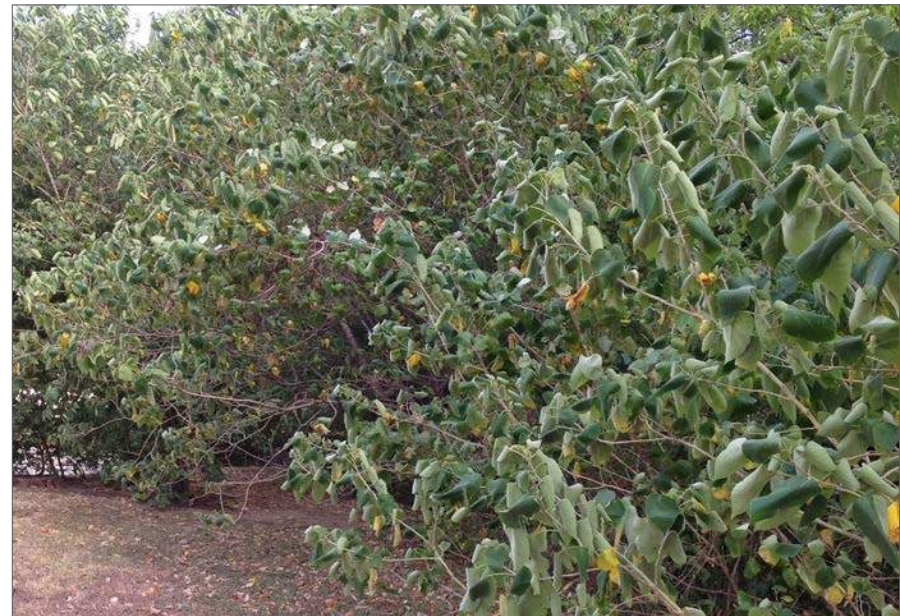
Figure 2.33 (Above): Giant reed can be seen in the foreground of this 1925 photo of Deep Eddy. Source: PTH. Figure 2.34 (Below, left): Giant reed forms dense monocultures along many sections of shoreline in the study area. Figure 2.35 (Below, right): Though not abundant in the study area, paper mulberry is highly problematic at Butler Shores Park.

Though it is only found in 3 locations in the study area, one of the patches—between the fields and the Trail at Butler Shores Park—is extremely dense and extensive, with very little native understory or herbaceous layer below.

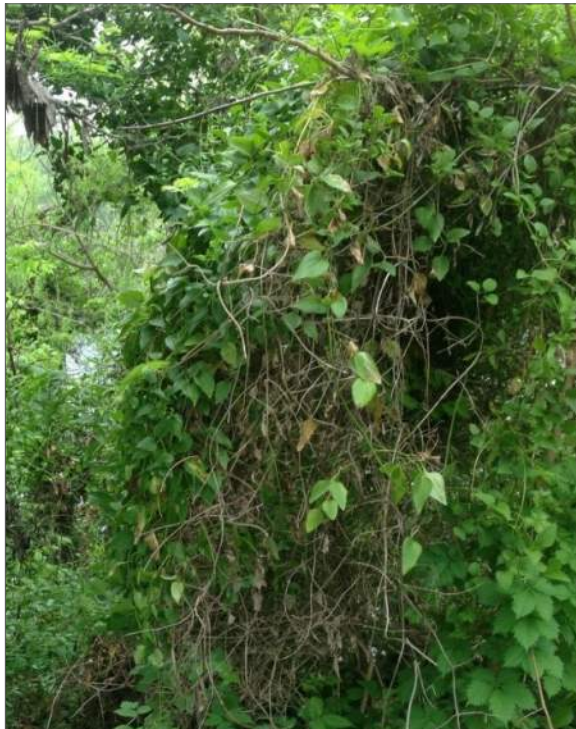
Sweet autumn clematis (*Clematis terniflora*) is a climbing vine that forms dense blankets over trees, shrubs, and other vegetation, blocking vital sunlight from reaching them, as shown in Figure 2.36. Dense patches are common throughout the entire study area. It is not listed as one of Austin's top 24 invasive species, but is ranked Moderate for the

Figure 2.36: Sweet autumn clematis forms a thick blanket over native vegetation.

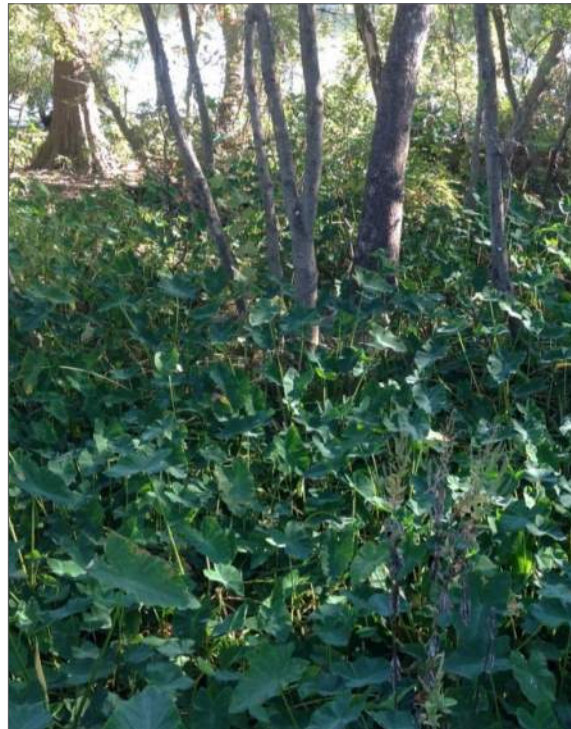
Elephant ear (*Colocasia esculenta*) is an aquatic plant present along the shoreline throughout the majority of the study area (Figure 2.37). As seen in Figure 2.38, elephant ear is not a new arrival in the study area. Large, dense monocultures of elephant ear crowd out native aquatic plants in many areas. Other sections of shoreline currently have more scattered, sparse instances of the species. This species is ranked as Moderate by the City of Austin and High for the study area.

Figure 2.37: Elephant ear grows densely on shorelines and low-lying areas.

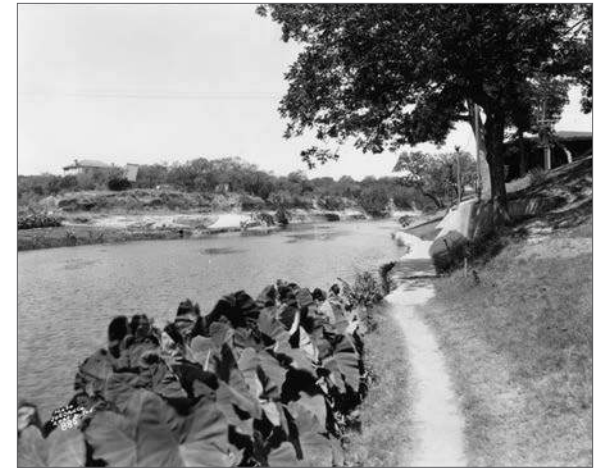
Figures 2.38 (Above): Elephant ear at Barton Springs Pool in 1925. Source: Jordan Company via PTH.  
Figure 2.39 (Below): Golden rain tree forms a near monoculture in the central north shore.

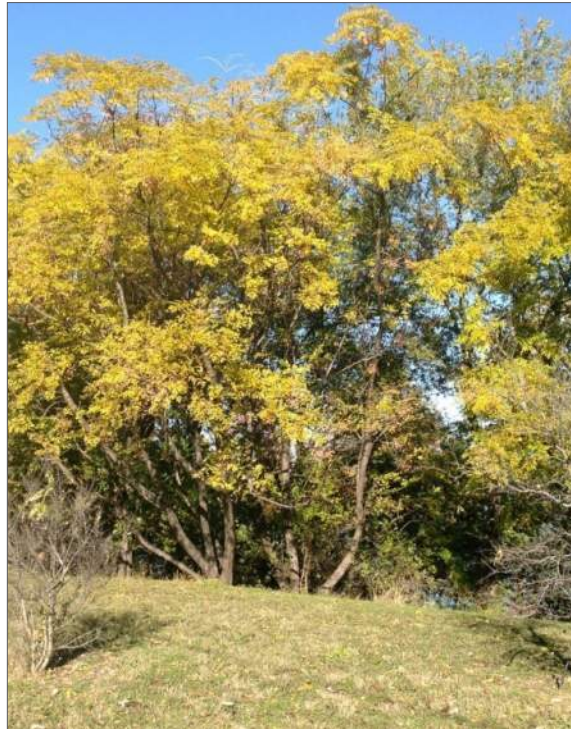
Figure 2.41 : Dense stands of Chinaberry crowd out native plants.

conditions for native plants. Chinaberry is common throughout the study area and has formed some dense stands, such as the one on the Southeast Shore shown in Figure 2.41. Both mature and young Chinaberry trees are abundant and could begin to form additional dense stands if left unchecked. This species is ranked High both by the City of Austin and within the study area.

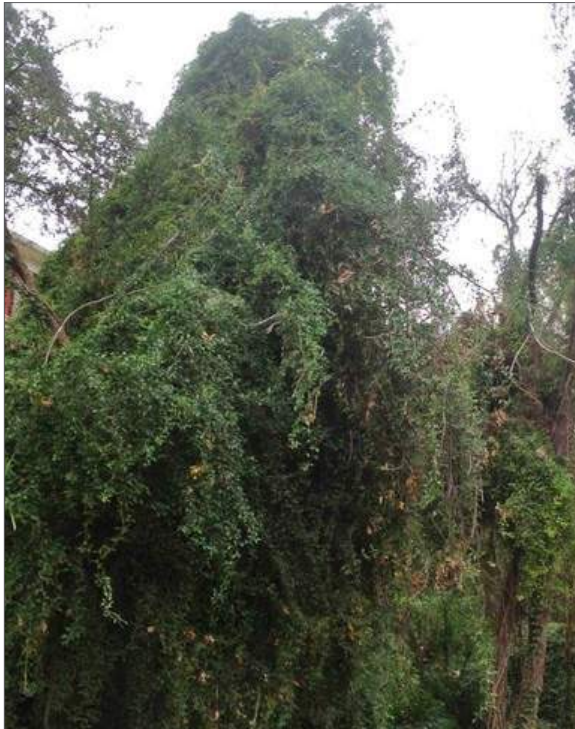
sive evergreen perennial that grows rapidly and can climb and overtop canopy trees, as shown in Figure 2.40. Difficult to control, it grows from underground tubers with vast stores of energy. It is currently found in only 5 parts of the study area, but is growing aggressively in those places. This species is given a Moderate ranking by the City of Austin, but a High ranking for the study area.

Figure 2.40 Catclaw vine smothers trees and other plants.

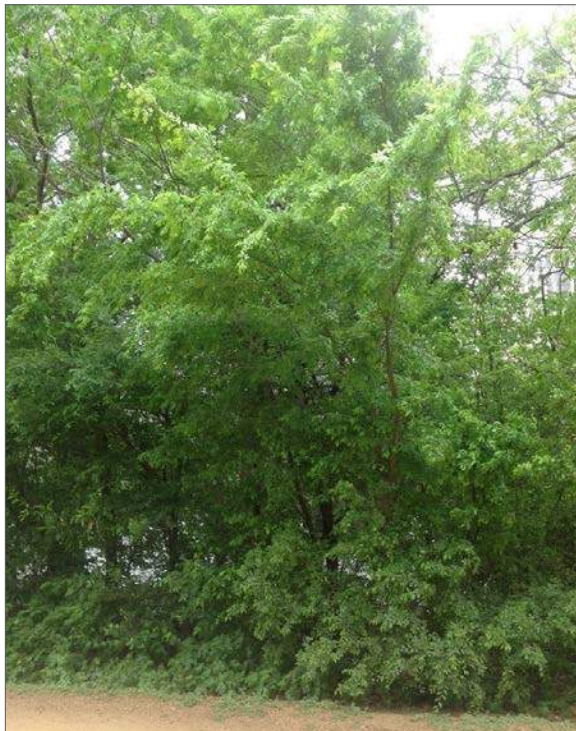
Figure 2.43: Chinese lacebark elm is growing very densely on portions of the north shore.

walk near the mouth of Blunn Creek. The species forms a near-monoculture along some sections of the northern shore of the Lake and is also abundant in limited portions of the south shore, as seen in Figure 2.43. These dense stands are less biodiverse than surrounding areas. Chinese lacebark elm is not included in the Top 24 Invasive Species in Austin list, but is ranked High for the study area.

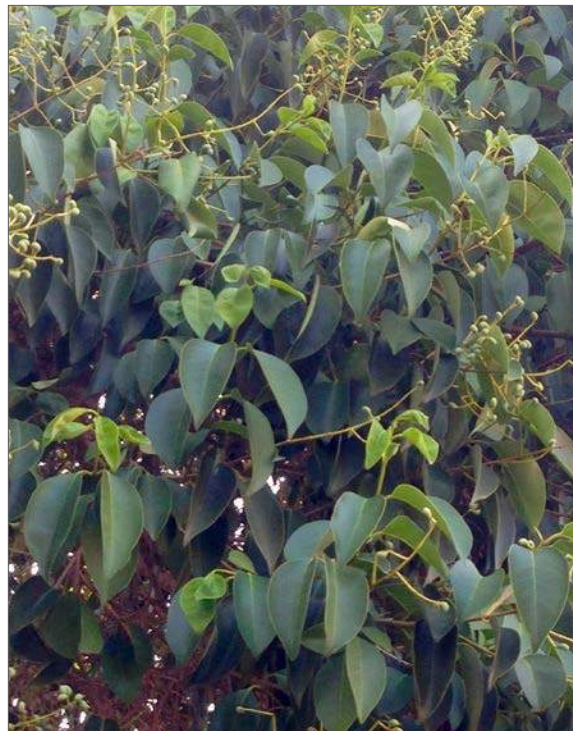
Figure 2.44: *Ligustrum* grows densely and quickly resprouts when cut.

vegetation (Figure 2.44). Within the study area, it is primarily present as scattered individual plants. With the exception of several dense patches, *Ligustrum* is not currently having a substantial impact in the study area. *Ligustrum* is ranked High by the City of Austin, but Moderate within the study area.

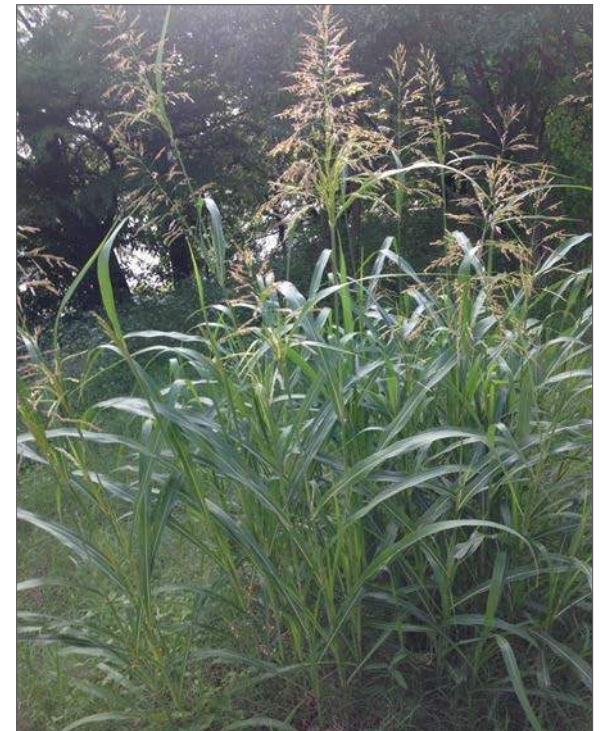
Figure 2.45: Johnsongrass is abundant in many Grow Zones.

es that are crowding out native species, as shown in Figure 2.45. Many of the open spaces where Johnsongrass would likely thrive are currently mowed, limiting its growth. This species is particularly dominant in many Grow Zones and could become increasingly problematic as more areas are managed as Grow Zones or otherwise converted to more natural vegetation. It is ranked High by the City of Austin and in the study area.

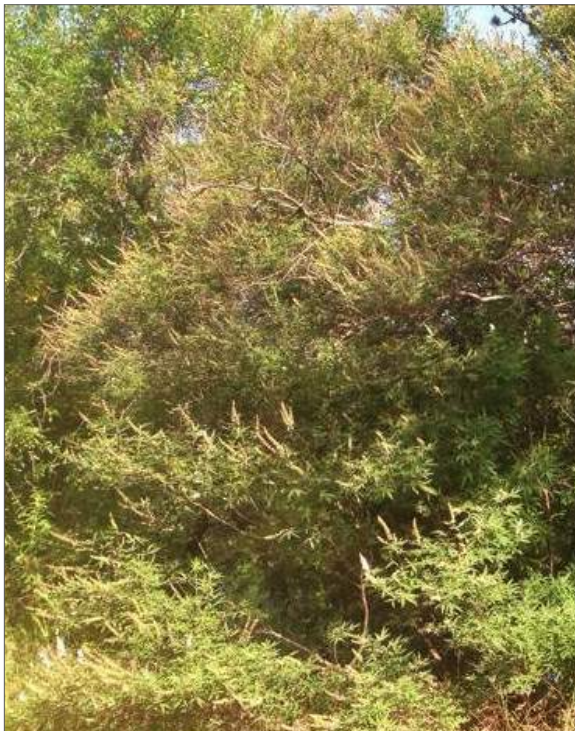
Figure 2.46: Common chaste tree is found along much of the shoreline and is growing densely in several locations.

native vegetation below, as seen in Figure 2.46. It is present throughout much of the study area, particularly in the eastern half. In most cases, it is present as scattered individuals rather than dense stands. The majority of the plants seen were mature; limited seedlings and young plants suggests that the population is currently not dramatically increasing. There are, however, several areas of dense growth earning the species a Moderate ranking for the study area even though it is not included in the Top 24 Invasive Species in Austin list.

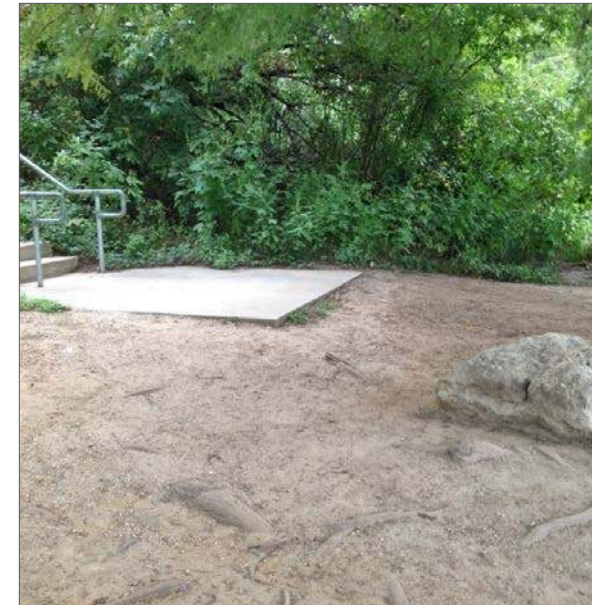
Informal trails are pathways created by human and dog traffic that are not maintained by the Parks and Recreation Department. Informal trails have trampled vegetation and compacted soils, as shown in Figure 2.48, and may lead to sheet erosion or the development of rills and gullies over time.

Figure 2.48: Informal trails have trampled vegetation and compacted soils.

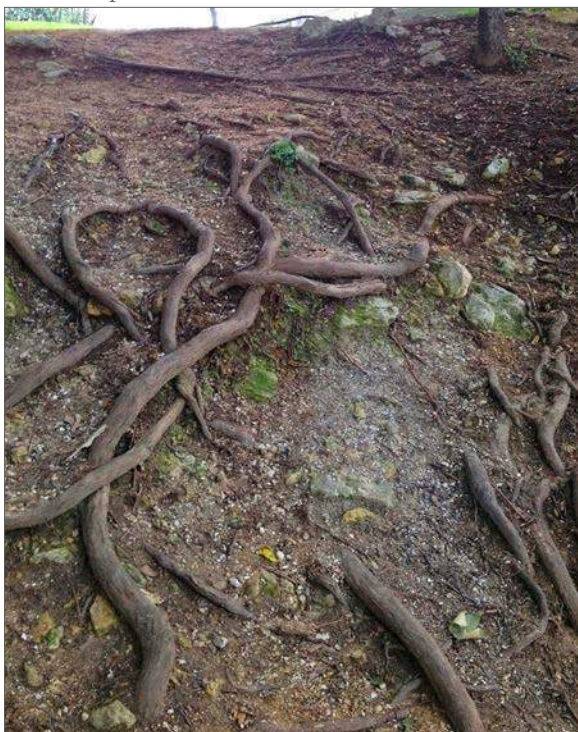
Sheet erosion is the removal of thin layers of soil due to precipitation and shallow surface flow. Along Lady Bird Lake, it is closely associated with the trampling described above and steep slopes. In many areas, tree roots are the only things preventing the disturbance from progressing into rill erosion, as seen in Figure 2.51. There is high potential for these areas to become worse as continued erosion undermines tree roots.

*Figure 2.51: Sheet erosion is most common on steep slopes and can expose tree roots.*

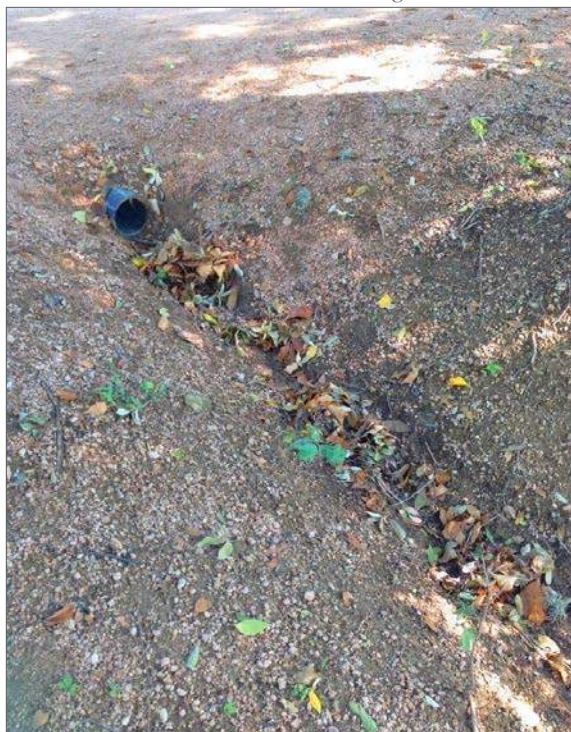
Rill erosion is the formation of one or more small channels less than 1 ft deep, like the one shown in Figure 2.52. If the conditions that led to their formation continue unchecked, these channels may deepen. Rill erosion is not concentrated in any one

*Figure 2.52: Rill erosion often occurs where culverts carry water under the Trail without armoring below.*

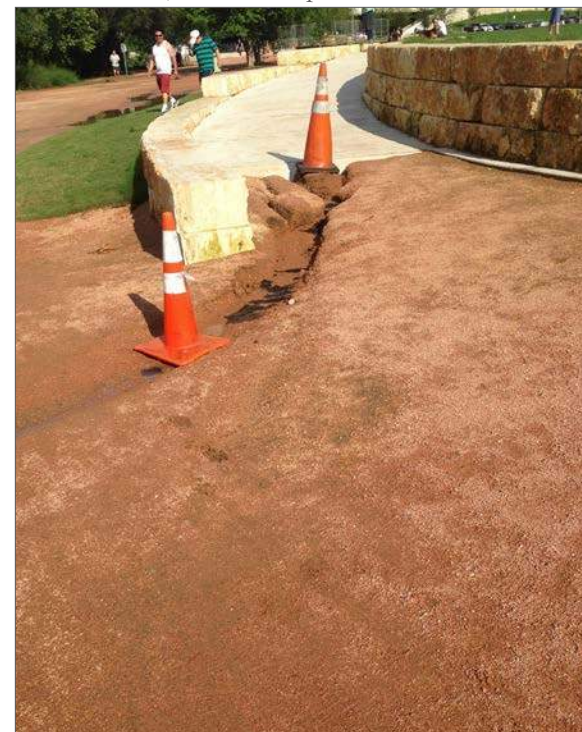
- Infrastructure that does not take into account the natural areas or is having unintended consequences—examples of this include culverts that bring water under the Trail but are not armored below their outlet, retaining walls that have large amounts of water flowing around their edges (as shown in Figure 2.53), and designed dips in the Trail without armoring or flow dispersers below.

*Figure 2.53: Rills can form when proper dispersal mechanism are absent, like this ramp at Auditorium Shores.*

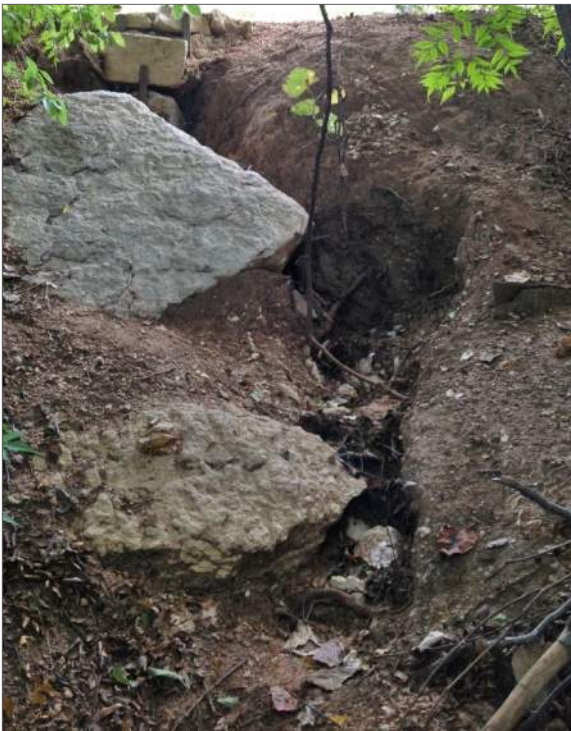
Gully erosion is a more advanced stage of rill erosion in which the incisions are 1 ft deep or more (Figure 2.54). It occurs most often in areas with long, steep slopes. Gullies that have not been armored or stabilized pose a threat to the Trail as they may eventually intercept and damage it.

*Figure 2.54: Gully erosion is a more advanced stage of rill erosion.*

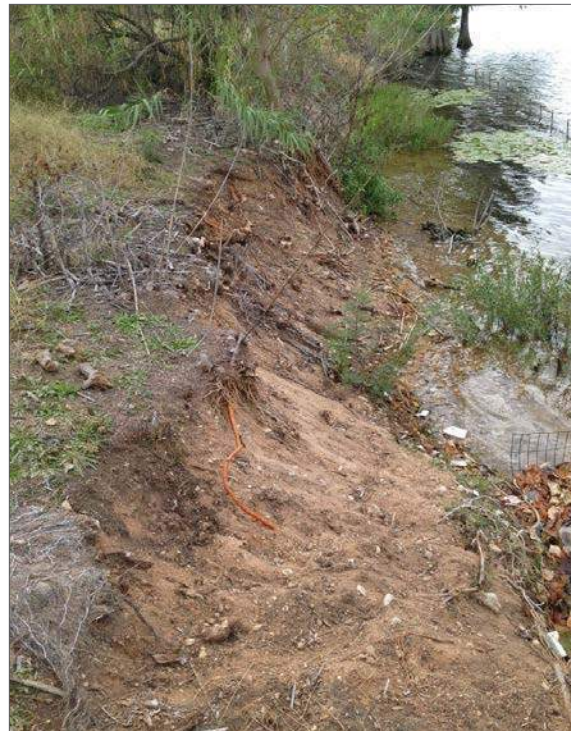
as downpours. Waller Creek exhibits the greatest amount of streambank erosion. Plans are currently underway to address Waller's erosion issues. Recent restoration work at Shoal Creek has mitigated some of the bank erosion. Minor lakeshore erosion is taking place in many places along Lady Bird Lake, particularly in areas where giant reed has been treated, as shown in Figure 2.55.

*Figure 2.55: Bank erosion often occurs where giant reed has been removed, such as this area near Longhorn Dam.*

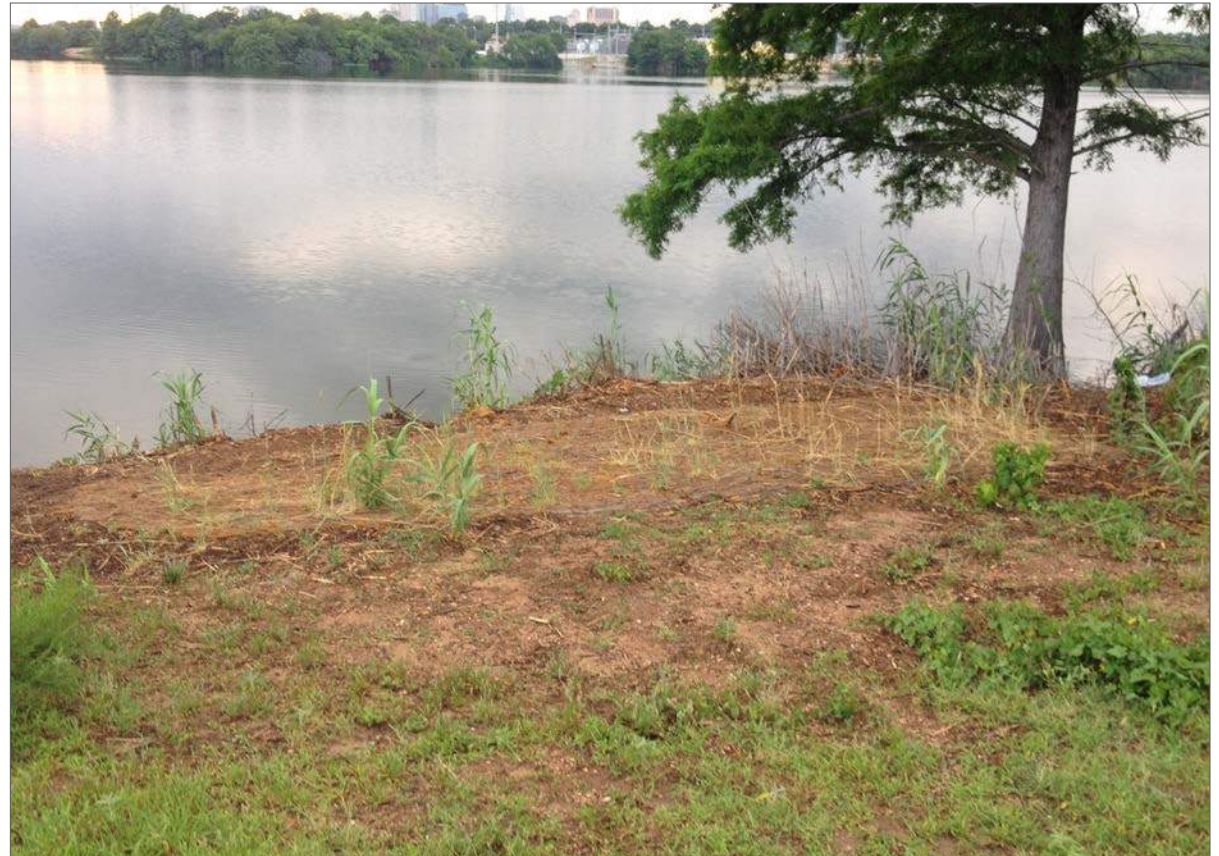
by the City of Austin, Siglo Group, the National Parks Service, and TexasInvasives.org. As these practices are implemented, it is critical to remember that invasive species control is a multi-step process. After an initial treatment, follow up treatments are the only thing that will keep the situation from regressing (Texas Invasives 2015). For example, many of the giant reed patches throughout the study area have been previously treated by the City's Watershed Protection Department, but are growing back and are currently in need of follow up treatment and restoration planting (Figure 3.3).

Figure 3.3: Giant reed resprouting after treatment.

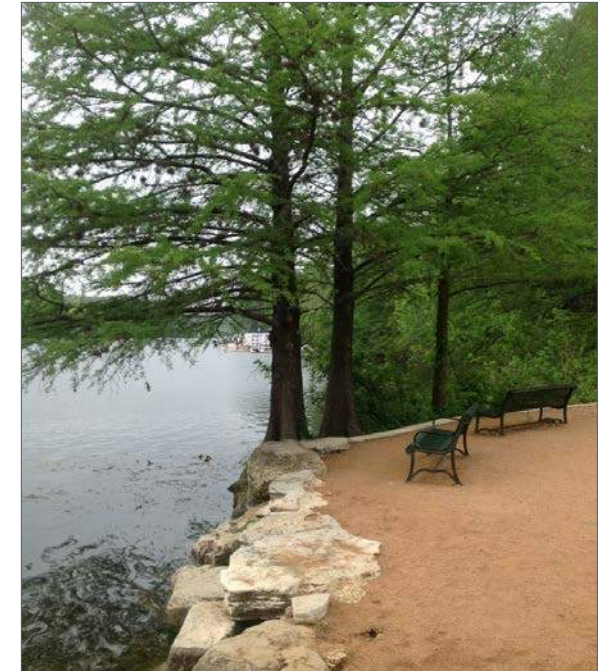
*Figure 3.4: Formal water access areas, like the "Northshore Overlook" installed by The Trail Foundation in 2006, allow visitors to engage with the water without causing damage to the sensitive lakeshore.*

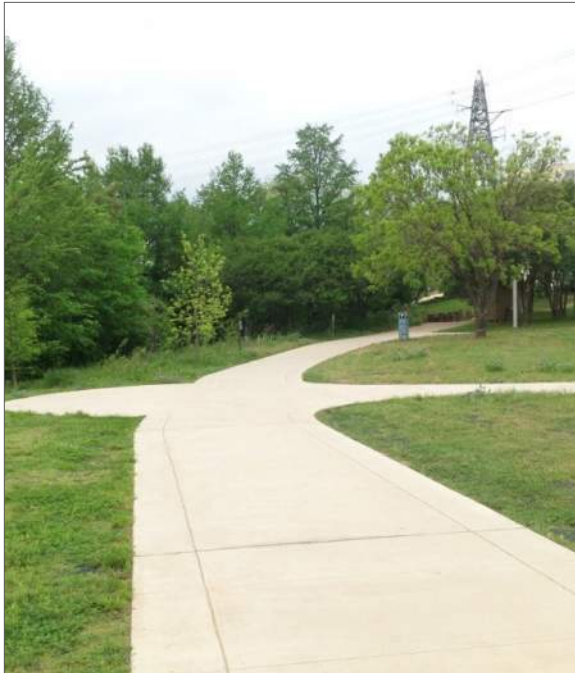
*Figure 3.5: In areas where the Trail cannot be moved away from the shore, such as the Shoal Creek peninsula, the surface should be stabilized by paving or other means.*

Stabilization of trail material can come in numerous forms, including paving (as seen in Figure 3.5), geocell systems, spraying a polymer on the crushed granite, or a ribbon curb on the downslope side of the trail. In all cases, the reduction of trail material entering the natural areas should be the measurement of success. These Trail criteria and stabilization options will result in a better user experience and healthier natural areas.

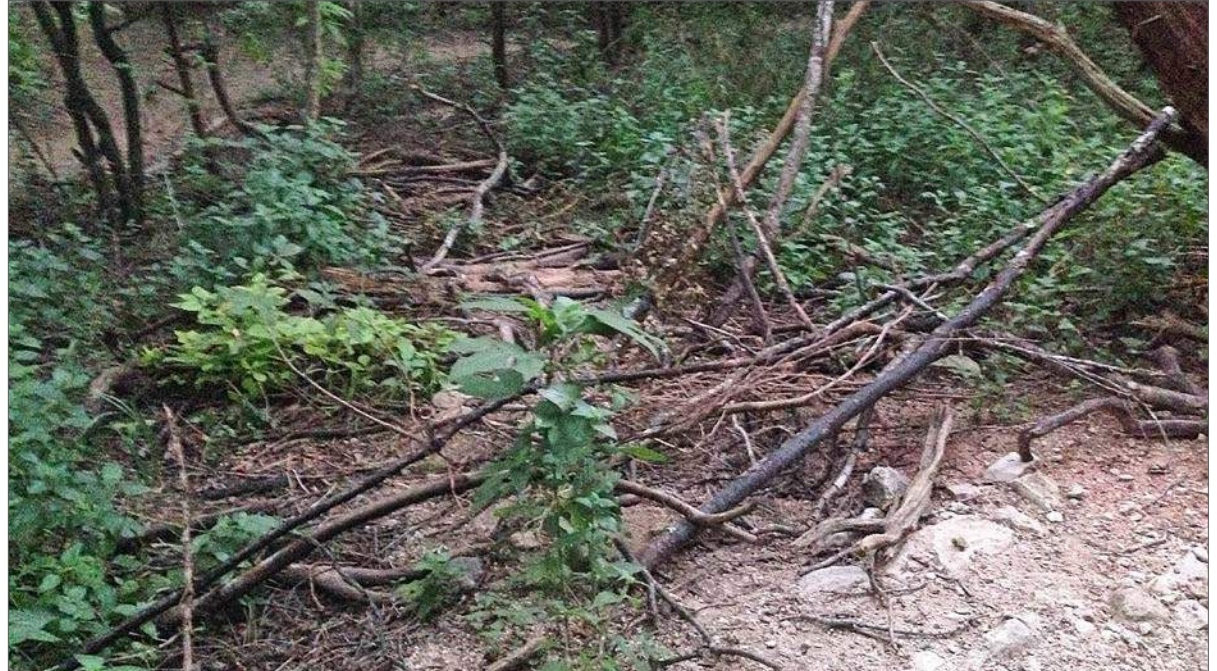
Figure 3.6: Brushing, as seen here on the Barton Creek Greenbelt, is an effective way to deter informal trail use.

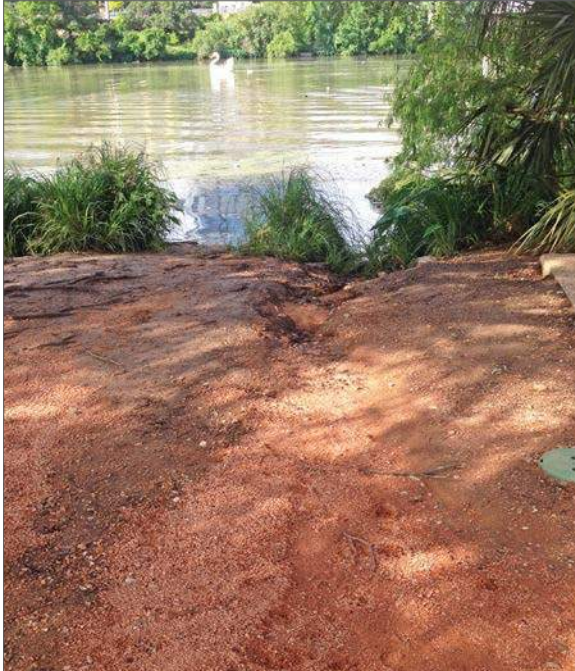
verts large amounts of fast-moving runoff onto the Trail, like the area shown in Figure 3.7.

*Figure 3.7: Runoff from infrastructure is causing rill erosion and erosion of trail material at Auditorium Shores.*

are caused by culvert discharges onto steep slopes. In these areas, water-dispersing armoring should be installed where feasible. A variety of materials may be used to disperse the water, including rip-rap, concrete, loose stones, and limestone block gabions. Native rock is the preferred material.
