# The Butler Trail at Lady Bird Lake

## Urban Forestry and Natural Area Management Guidelines

The Trail  
Foundation

*Produced by Siglo Group, 2015*

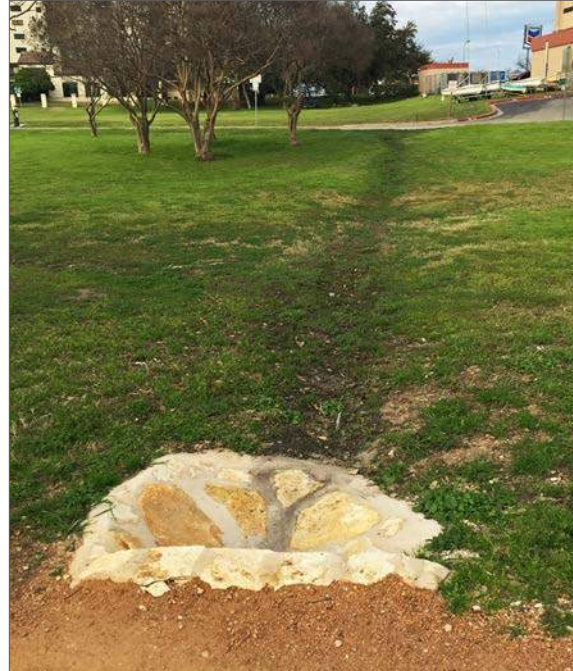
*Figure 3.8: One of the locations where creation of streamlets is recommended in the Rainey management unit.*

Stormwater moving across the study area at regular intervals, when accommodated, is a useful resource. The recommendations above address areas where it is not currently being accommodated. In a few instances, it is possible to utilize the existing erosion channel to create a streamlet within the study area. A streamlet is simply a small drainage channel. Where they occur naturally in central Texas, they are filled with plants that do not require consistently wet soils but thrive in seasonally wetter soils, such as Lindheimer's muhly and seep muhly. Formalizing the existing channels by reinforcing the erosion bed with rock and gravel, planting appropriate plants, and reducing mowing frequencies to once a year or less will prevent erosion issues, accommodate the water flow, and create a more dynamic environment in the natural areas. There are two sites near Rainey Street (one is shown in Figure 3.8) and two sites in Festival Beach where this technique is recommended, as discussed in the Management Units chapter.

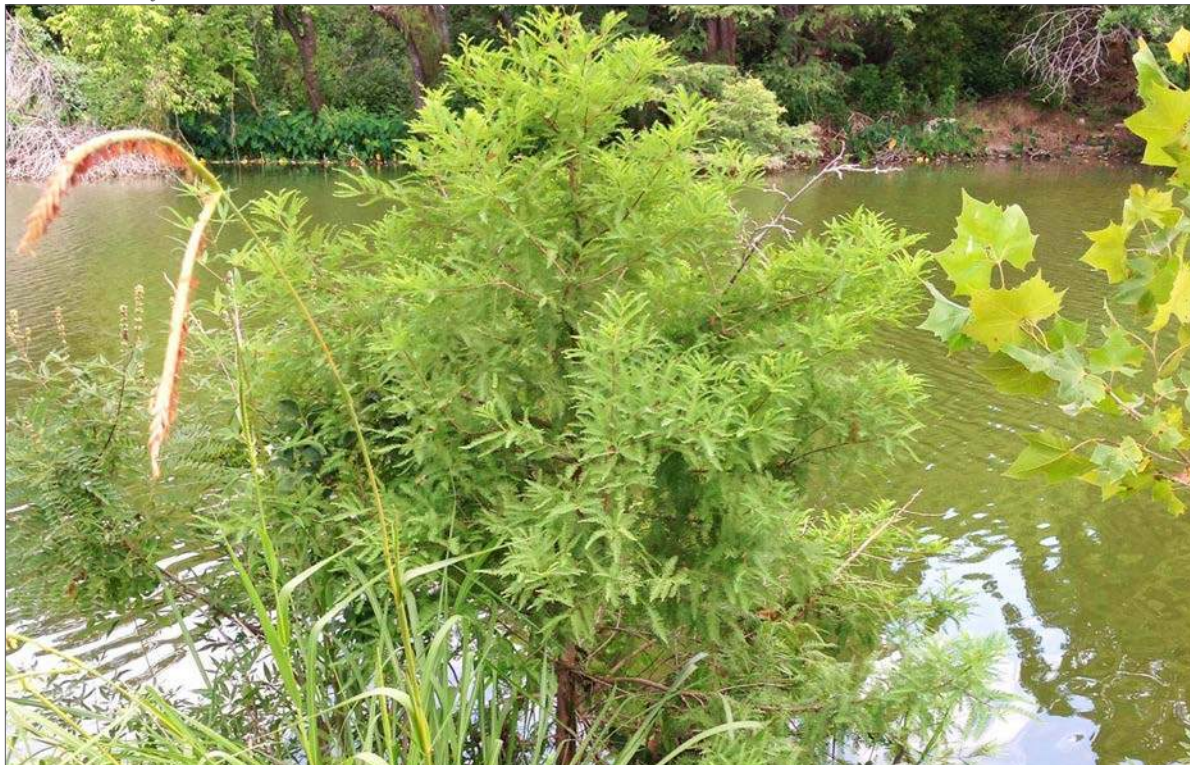
Figure 3.10: Planting shoreline species like bald cypress and eastern gamagrass close to the water will greatly increase the likelihood of restoration success.

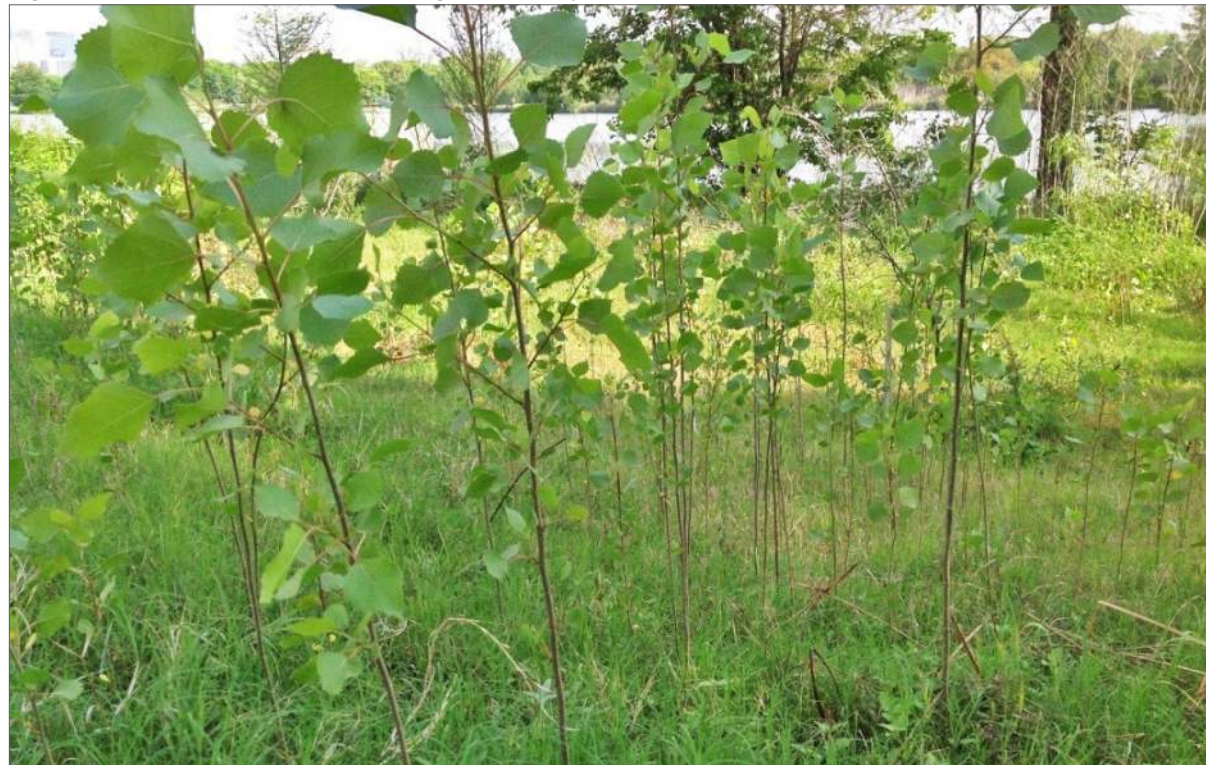
*Figure 3.11: Abundant cottonwood seedlings in a recently converted Grow Zone in the Southeast Shore.*

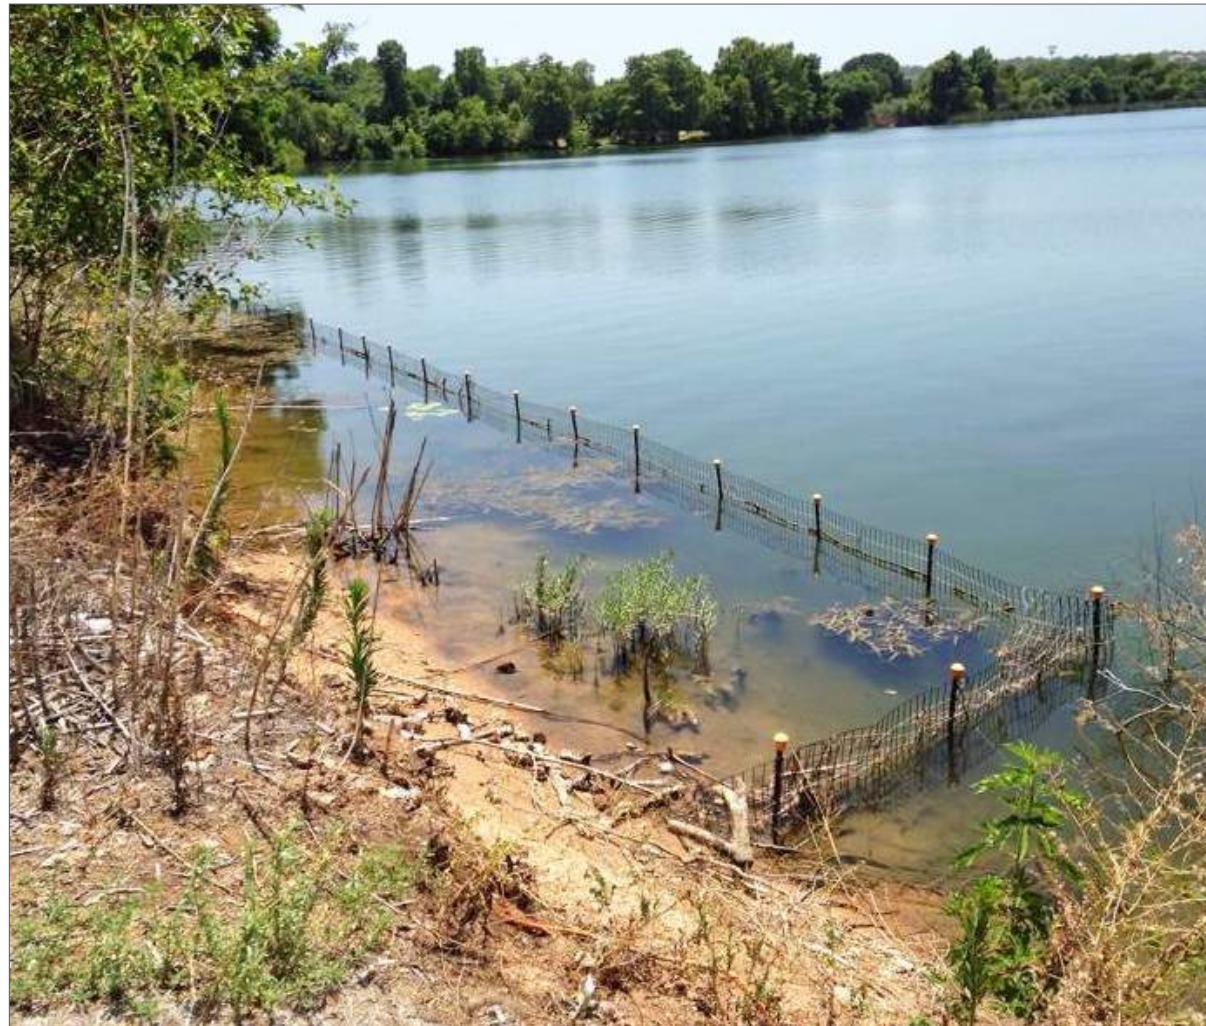
*Figure 3.12: Exclosures are recommended for some aquatic plantings to protect against herbivory.*

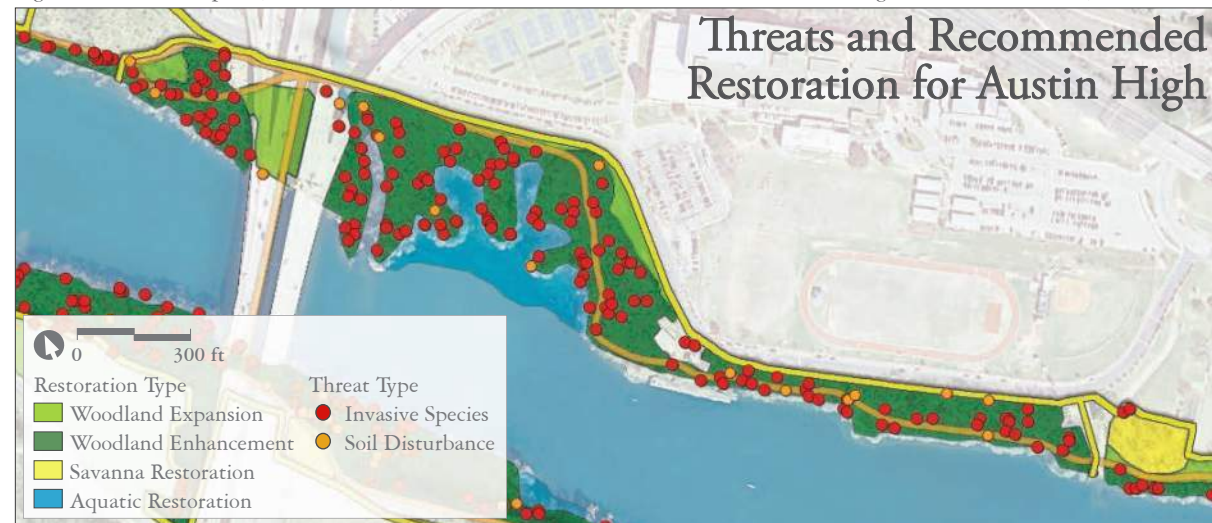
Figure 4.9: Invasive species, erosion issues, and recommended restoration areas in the Austin High Unit. Sources: COA, NAIP.

Management in this area should focus on enhancing the relatively intact woodland in this unit while addressing acute issues. In the woodlands and associated aquatic areas, efforts should focus on invasive species removal, general cleanup, and increasing plant diversity through planting and seeding. In the eastern portions of the unit, the Trail should be shifted several feet inland and the trail surface should be stabilized. This change will necessitate restoration plantings. Two informal trails between Veterans Drive and the Trail and one in the wooded peninsulas should be formalized and the rest should be decommissioned. As resources become available, the area under MoPac can be restored. Work under the highway has great potential to expand the natural areas but will need to address stormwater issues, soil decompaction, and a lack of direct sun for most of the area.

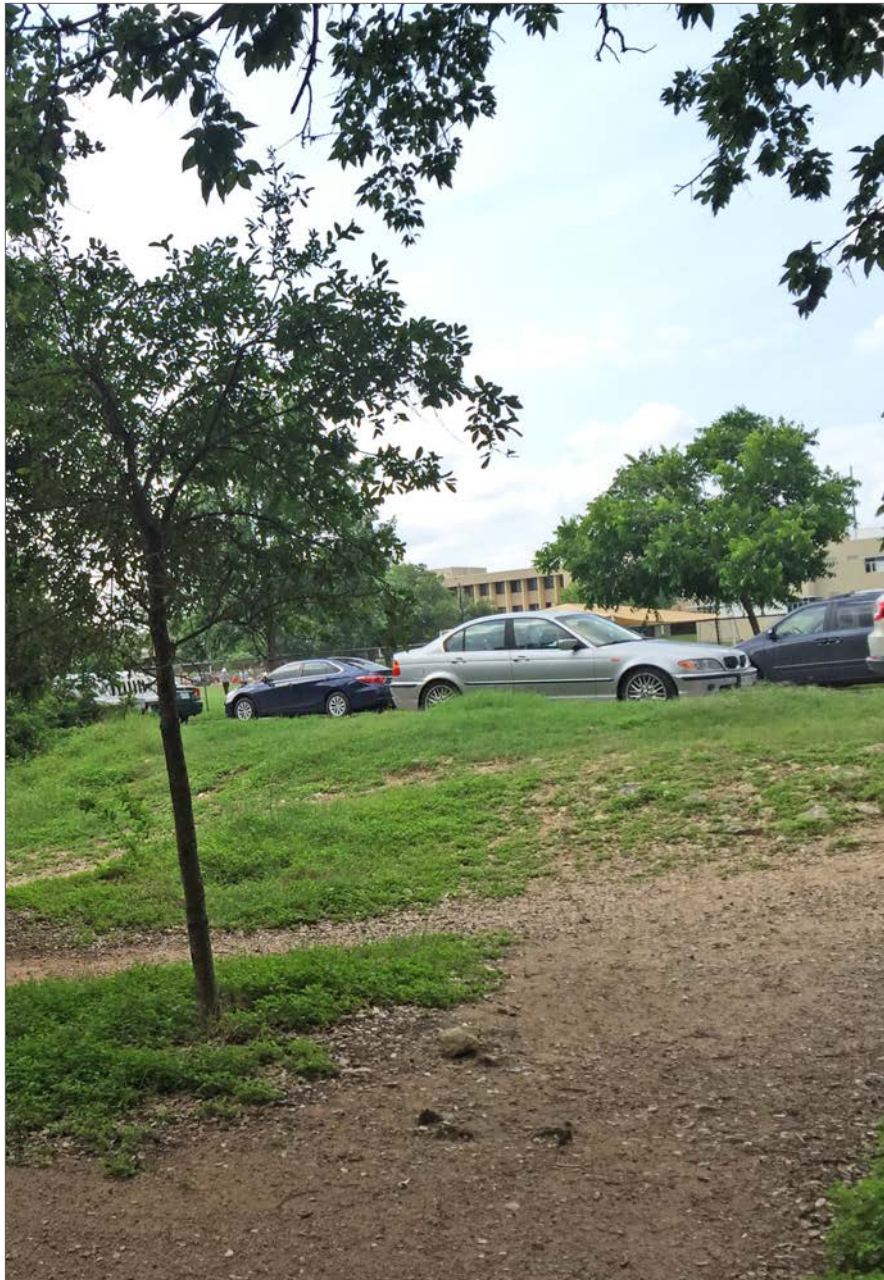
Figure 4.10: One of several of the heavily used informal trails between Veteran's Drive and the Trail.

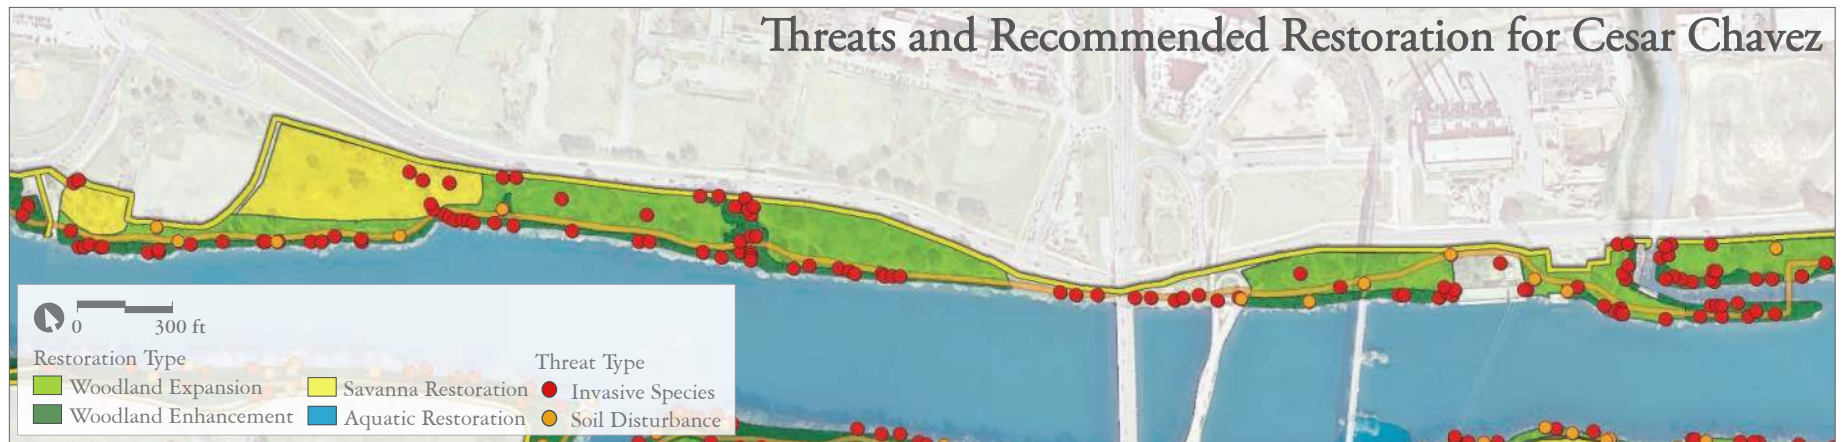
Figure 4.13: Invasive species, erosion issues, and recommended restoration areas in the Cesar Chavez Unit. Sources: COA, NAIP.

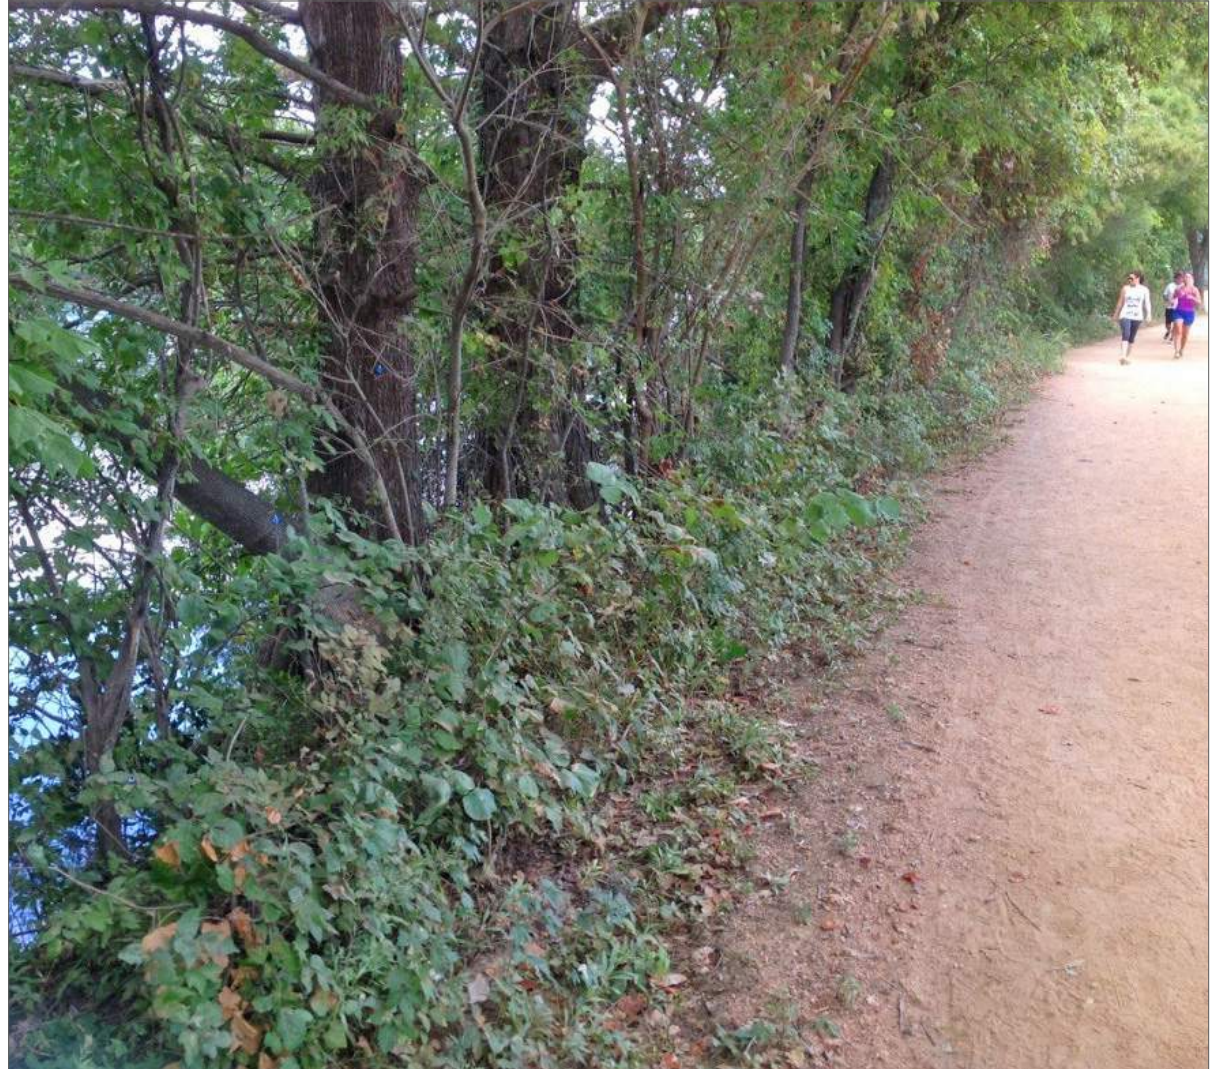
*Figure 4.14: The Trail is extremely close to the Lake in parts of the Cesar Chavez unit. Trail realignment would allow for a wider riparian edge.*

from commonly wet areas and allow for a larger riparian edge (Figure 4.14). As resources become available, restoring savanna plant communities in the Gaddy soils can make this a unique site among protected lands in Travis County.

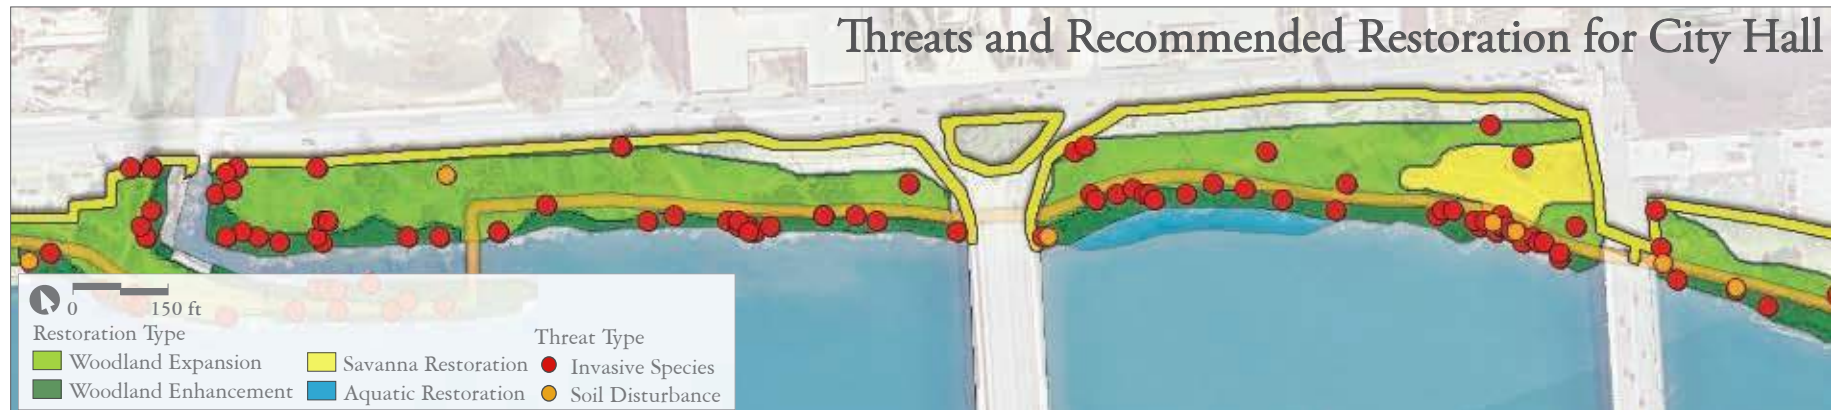
Table 4.6 (Above, left): Tree summary for all trees  $\geq 8"$  diameter in the City Hall Unit. Figure 4.16 (Above, right): Some sections have a delayed mowing schedule to allow for spring wildflowers. Figure 4.17 (Below): Invasive species, erosion issues, and recommended restoration areas in the City Hall Unit. Sources: COA, NAIP.

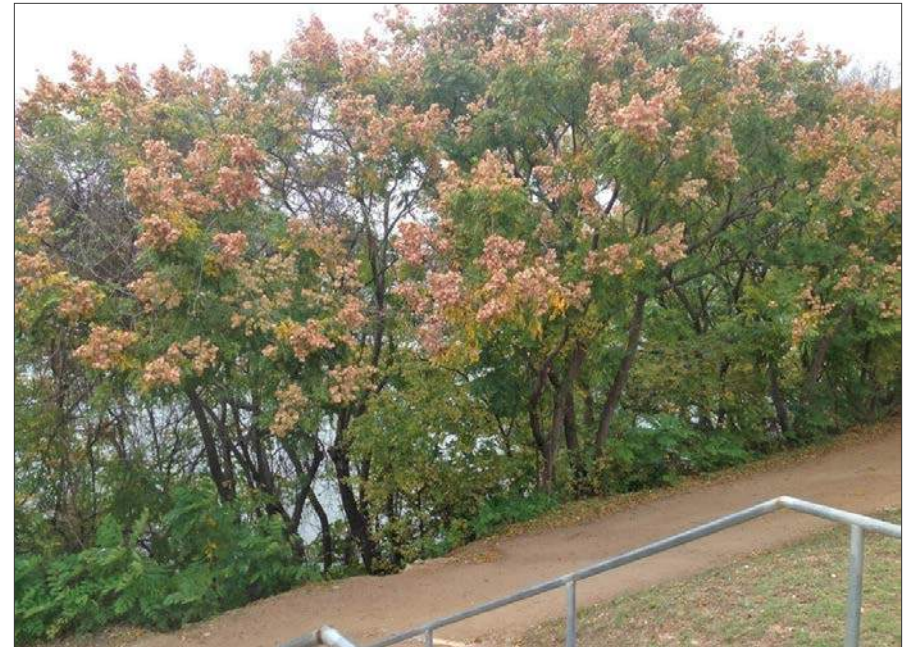
Figure 4.18 (Above): Golden rain tree dominates much of the woodland in the City Hall Unit.

In the woodland area, invasive species infestation is extensive, with 26 inventoried invasive trees per acre. This is by far the highest density of inventoried ( $\geq 8$ " diameter) invasive trees in the study area. Golden rain tree is rampant between 1st Street and Congress Avenue (Figure 4.18). Chinese lacebark elm, Chinese tallow, sweet autumn clematis, and giant reed are present, along with substantial stands of elephant ear at the Lake's edge. Chinaberry is another common woodland invader and is also present in the mowed areas.

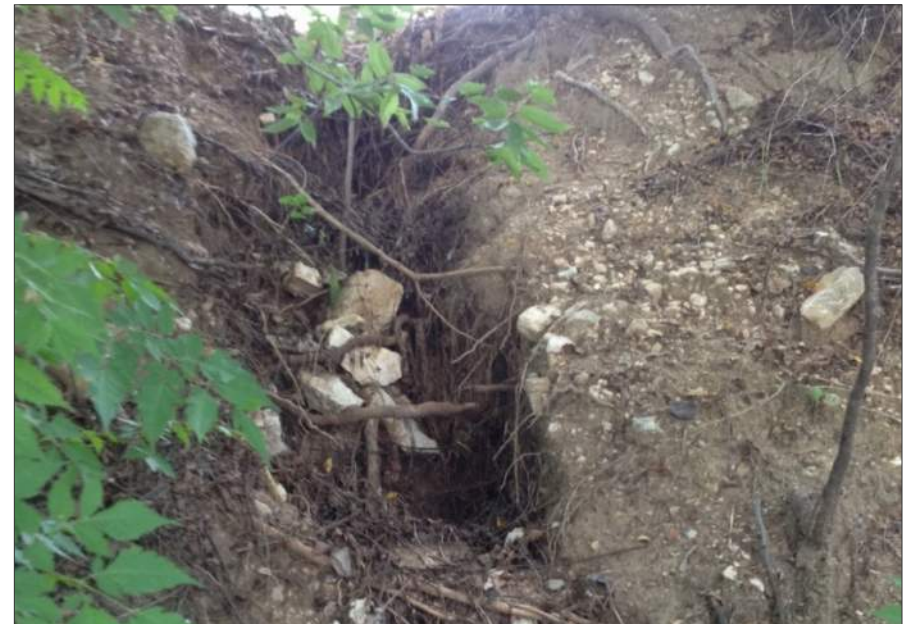
Figure 4.19 (Below): Gully erosion west of Congress Avenue Bridge.

There is gully erosion just west of Congress Avenue Bridge (Figure 4.19). The lawn area just east of Shoal Creek has been used as a staging area during restoration work at Shoal Creek and has compacted soils.

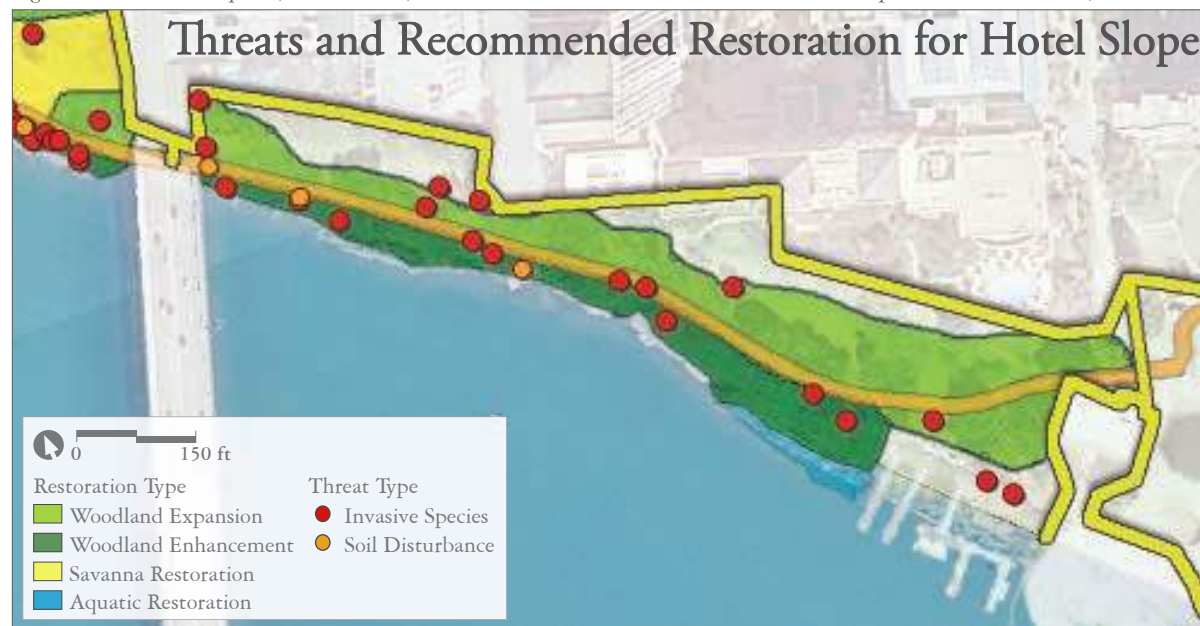
Figure 4.22: Invasive species, erosion issues, and recommended restoration areas in the Hotel Slope Unit. Sources: COA, NAIP.

The unit's ecological function and user experience can be improved by converting portions of the Bermuda grass and St. Augustine lawn area to woodland. Increasing the amount of woodland would also support the work of the City's Urban Forestry Program, which has deemed the census tract containing the Hotel Slope Unit a high priority for tree planting (Halter 2014). In addition, repair and improvement of dilapidated water access points would improve the user experience and reduce trampling issues. The wetland area near the boat docks can be protected and enhanced through the addition of sediment capture structures and aquatic plantings.

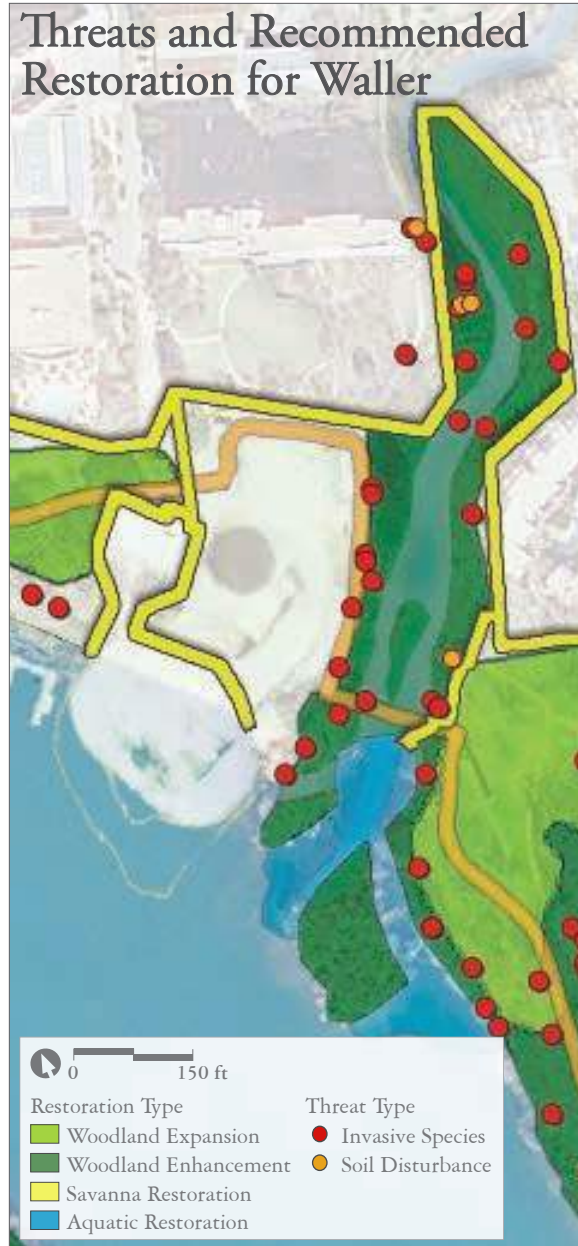
Figure 4.26: Invasive species, erosion issues, and recommended restoration areas in the Waller Creek Unit. Sources: COA, NAIP.

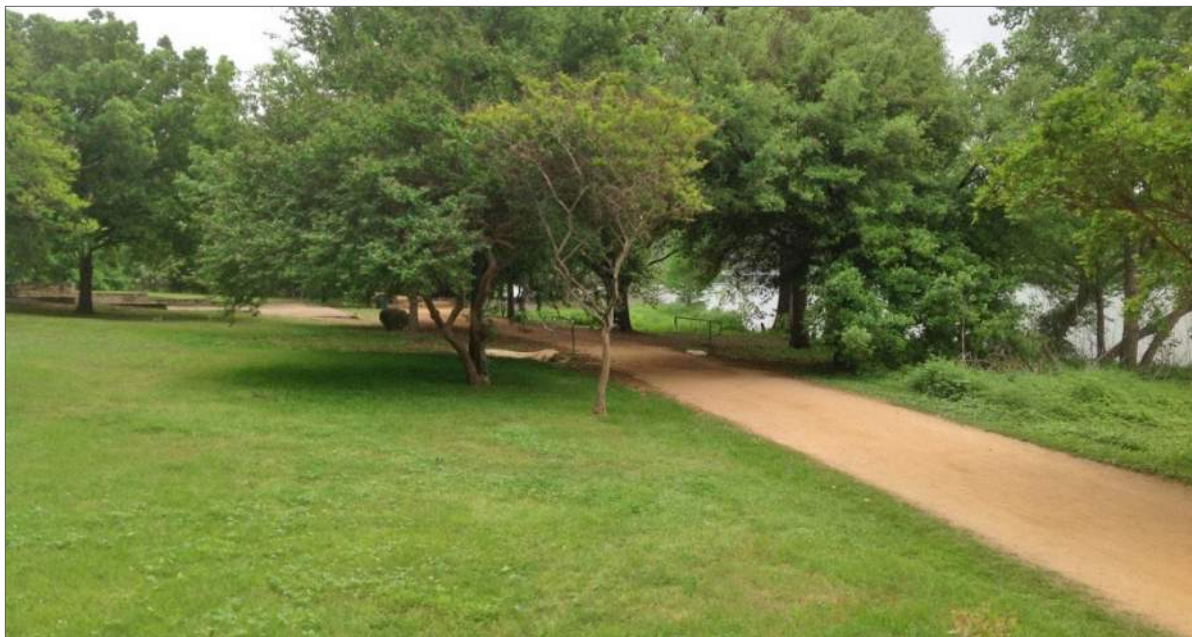
Figure 4.28 (Above): Much of the Rainey Unit is underutilized lawn. Figure 4.29 (Below): Staircase ends without infrastructure to access water, causing extensive trampling.

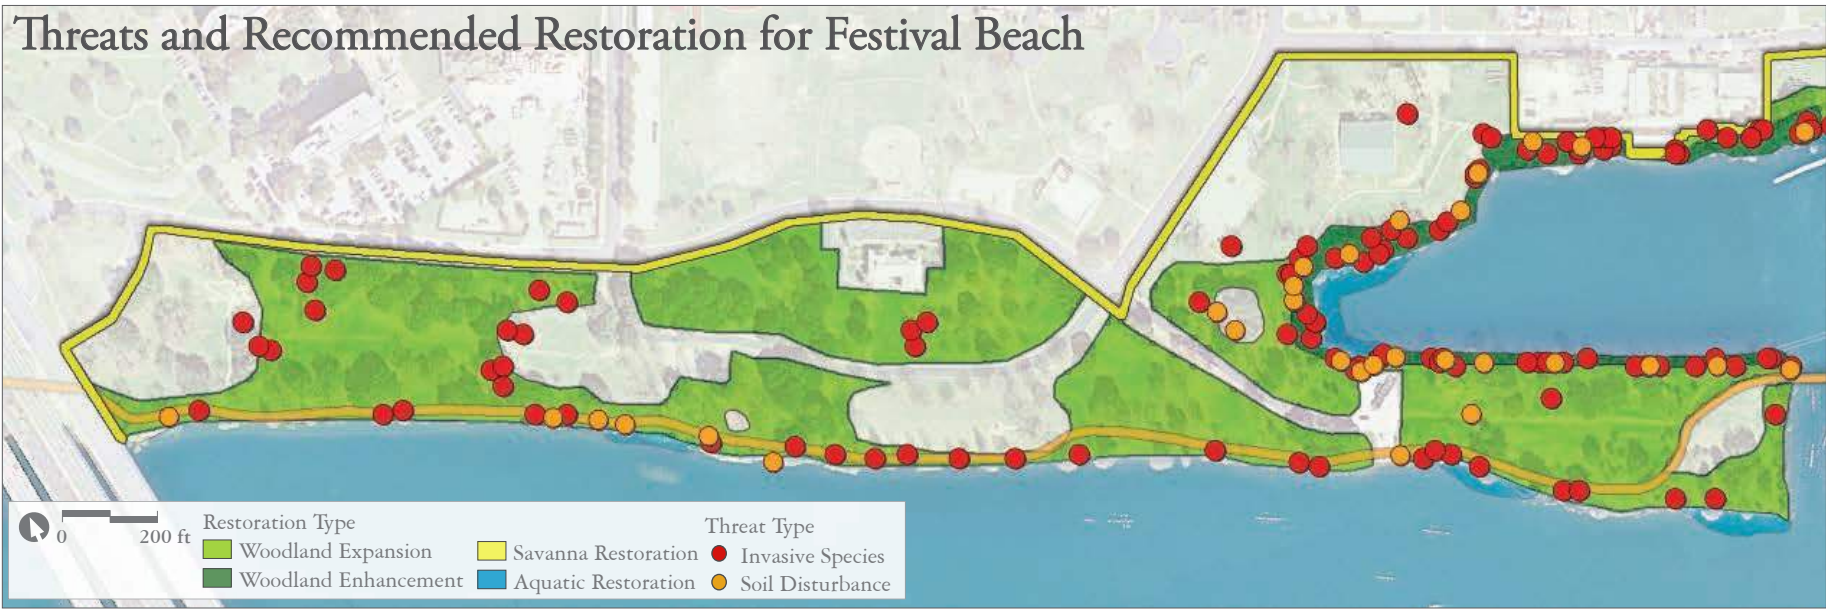
Figure 4.32: Invasive species, erosion issues, and recommended restoration work in the Festival Beach Unit. Sources: COA, NAIP

Major recommendations for this unit include woodland expansion into some of the large areas of underutilized lawn and relocation of portions of the Trail away from the water's edge to allow for a more stable trail and a healthy riparian edge. Expanding the woodland here is in line with the work of the Urban Forestry Program, which has deemed the census tract containing Festival Beach a high priority for tree planting (Halter 2014). The live oak groves pointed out in Don Gardner's report should be pruned. They are located south of Nash Hernandez Street between I-35 and nearest parking lot, north of the same parking lot to the old Aquatic Center, the Love of Christi Grove, and north of the eastern end of Nash Hernandez, just west of Fiesta Gardens.

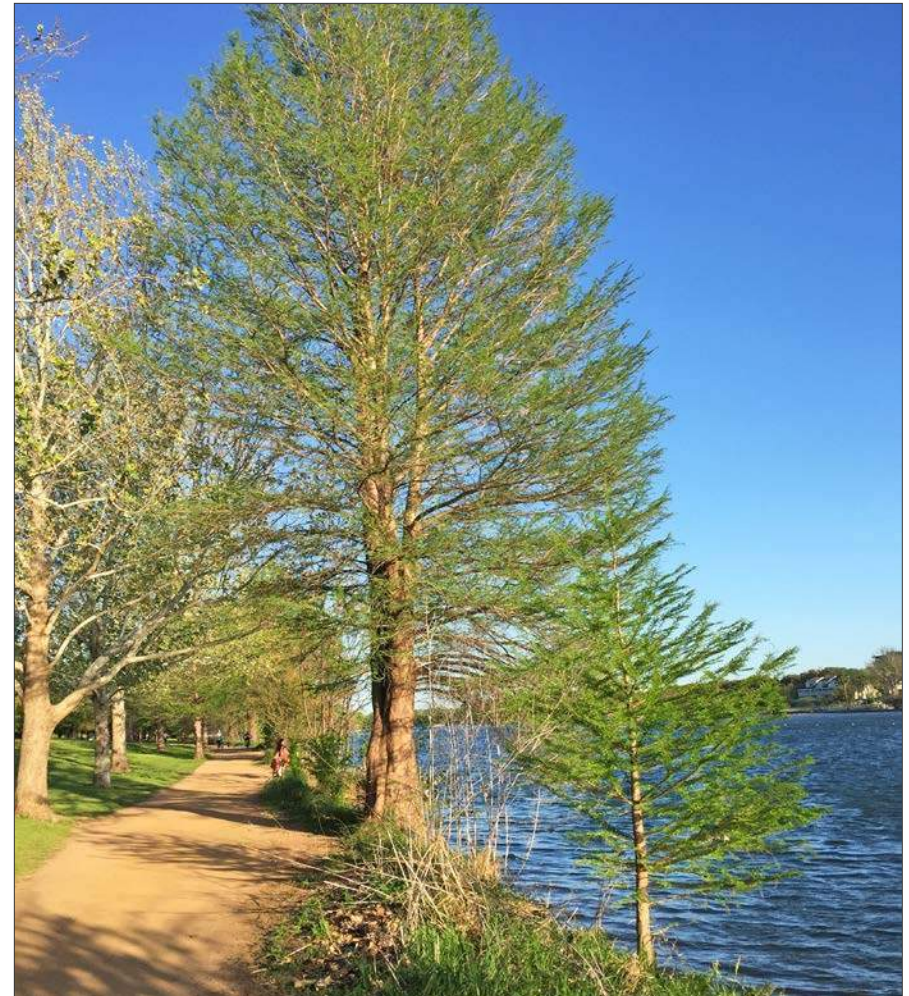
*Figure 4.33: The majority of the Festival Beach unit has only a thin strip of vegetation between the Trail and the shoreline and has scattered trees rather than a continuous canopy.*

This is a relatively flat, wide management unit where the Trail stays very close to the shoreline, with an expansive mowed area to the north. The majority of the Trail is within 15 ft of the Lake and some areas are less than 5 ft from the Lake, like the area shown in Figure 4.33. While there are numerous trees in Festival Beach, including many Heritage Trees, there is almost no continuous canopy and the riparian area is heavily impacted. The proximity of the Trail to the water is degrading existing vegetation, causing trail erosion, and inhibiting regeneration of the woodland canopy and understory plants. There are only 1.8 trees per 100 ft of shoreline, the fewest of any management unit. There are, however, a number of good specimens of bald cypress, pecan,

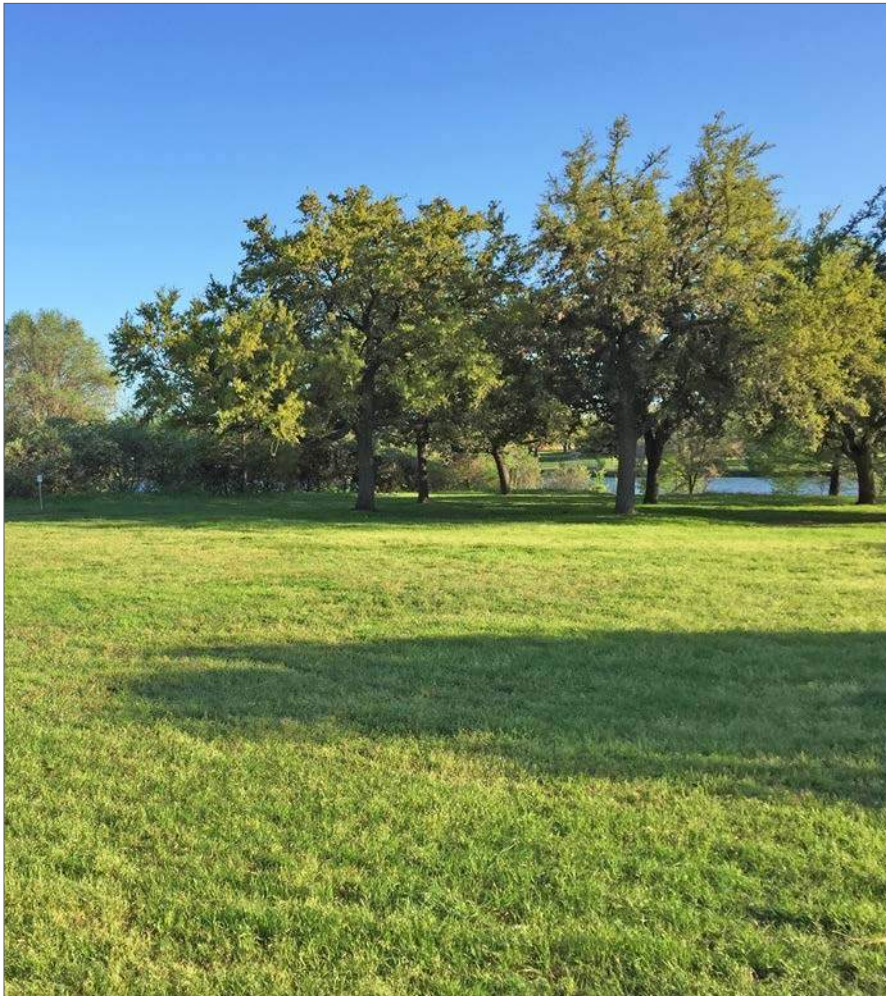
Figure 4.34: Festival Beach consists primarily of large underutilized lawns.

The vast majority of the management unit is mowed lawn, with shade trees and ornamental shrubs throughout (Figure 4.34). Live oak is the most abundant species, though crepe myrtle, pecan, Spanish oak, chinquapin oak, cedar elm, and Chinese tallow are also common. There are 125 Heritage Trees in the Festival Beach lawn, the majority of which are live oaks. Most of the remaining Heritage Trees are pecan or Spanish oak. The overall density of trees and shrubs large enough to be inventoried is 17 per acre, but the distribution of those trees is highly variable. There are several dense groves of live oaks

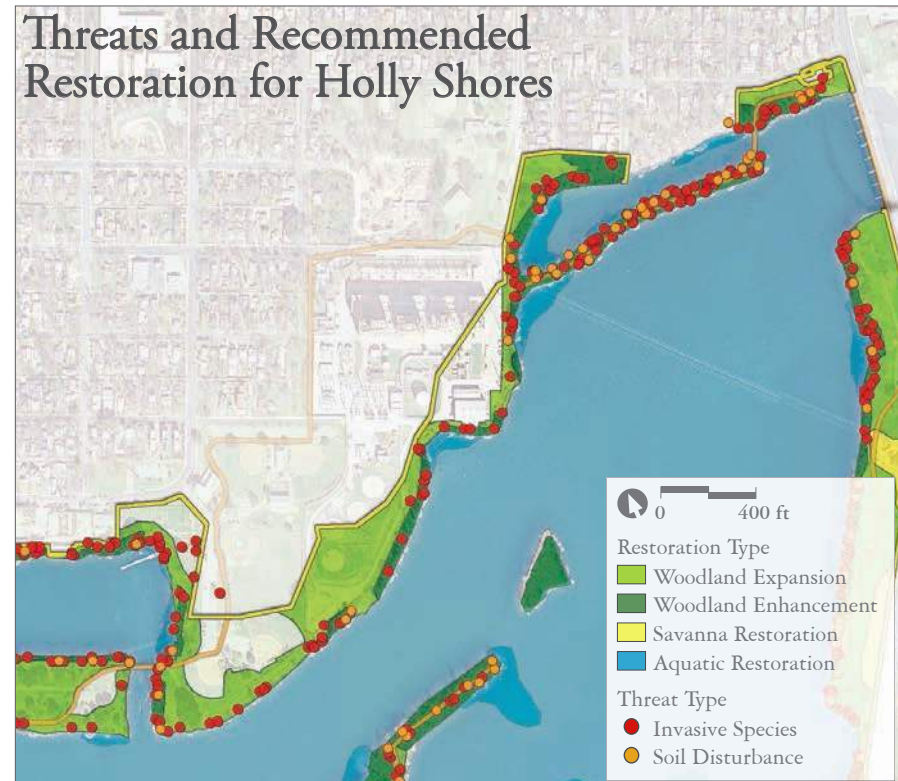
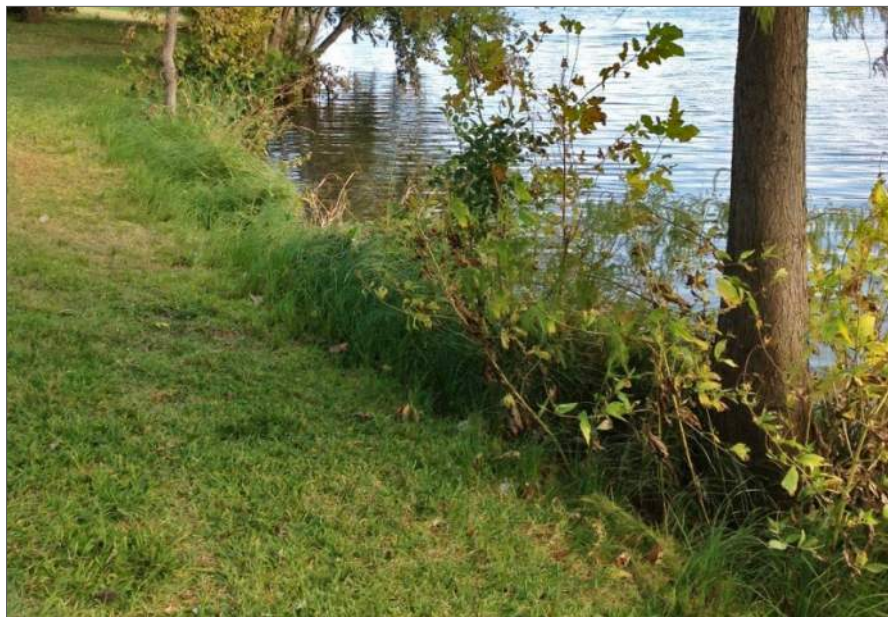
Figure 4.38 (Above): The strip of vegetation between lawn and Lake is extremely narrow south of the baseball fields. Figure 4.39 (Below): Trail material extends well beyond the width of the Trail on portions of the peninsula.

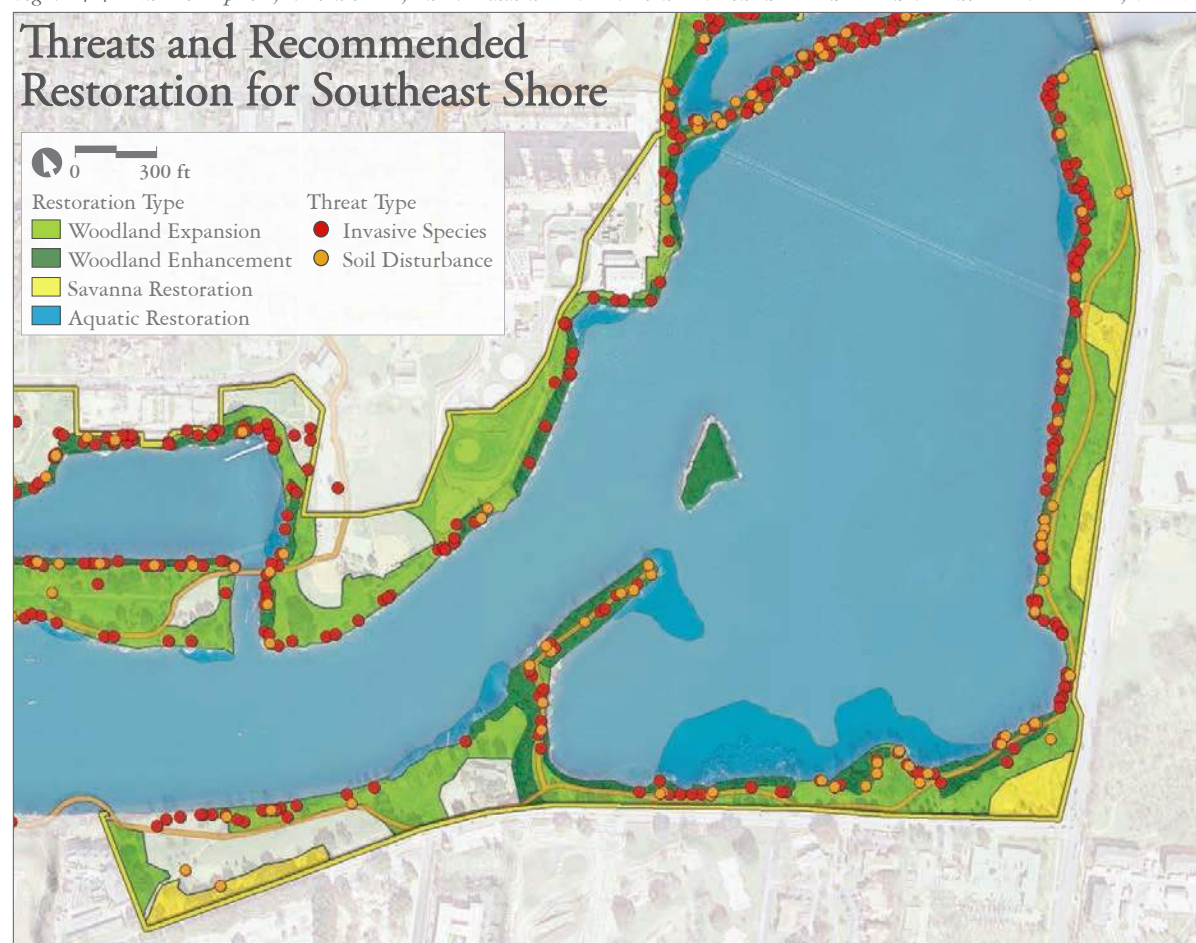
Figure 4.41: Invasive species, erosion issues, and recommended restoration work in the Southeast Shore Unit. Sources: COA, NAIP.

expansion to increase overall canopy, shading, ecological function, and to passively control giant reed along the shore. Before planting occurs, grading changes should be made at erosion points to slow down and retain water and reduce erosive effects of stormwater. Gaddy soils also occur in this unit, making savanna restoration a long-term goal for

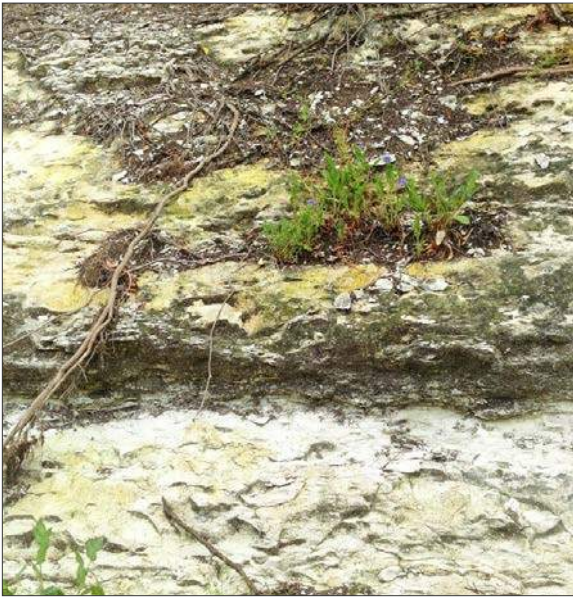
Figure 4.45 (Above, left): The exposed rock cliffs in this unit are unique within the study area. Figure 4.46 (Above, right): Many plantings have recently been added to the wetland surrounding the mouth of Blunn Creek. Figure 4.47 (Below, left): Invasive species, erosion issues, and recommended restoration work in the The Cliffs Unit. Sources: COA, NAIP. Figure 4.48 (Below, right): The largest infestation of catclaw vine in the study area is found in The Cliffs.

This is the only unit that contains exposed limestone bluffs (Figure 4.45), defined by the City as Critical Environmental Features. The bluffs have populations of Mexican Buckeye, wafer ash, Eve's necklace, and shrubby boneset, which are either absent or rare along the rest of Trail. The wetland at the mouth of Blunn Creek is undergoing a substantial restoration project by The Trail Foundation (Figure 4.46).

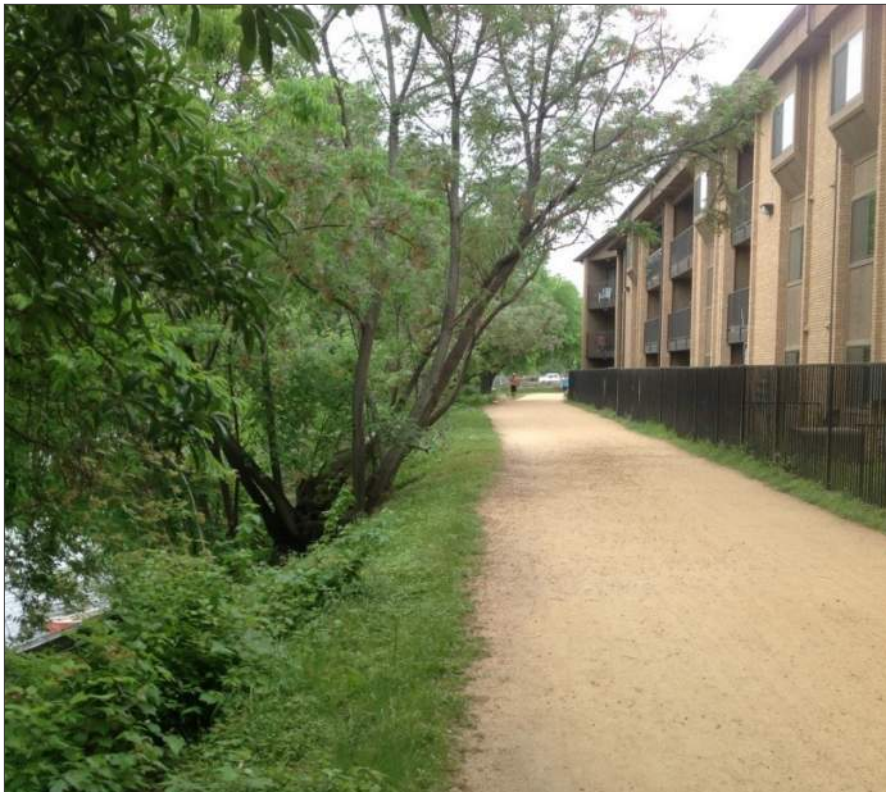
*Figure 4.50: In this unit, the Trail runs through a narrow easement on private property.*

through an easement on private property rather than through public parkland (Figure 4.50). Though it is narrow, the woodland makes up 2 acres. Bald cypress is the dominant overstory tree, making up over half of the trees surveyed. The vast majority of the trees in the unit are considered shoreline trees, for a total of 6.8 trees per 100 ft of shoreline. Though the number of trees in the area is comparable to other units, the basal area is relatively high due to the high number of large bald cypress. The understory in the woodland is variable. There are pockets of comparatively intact native understory and groundcover,

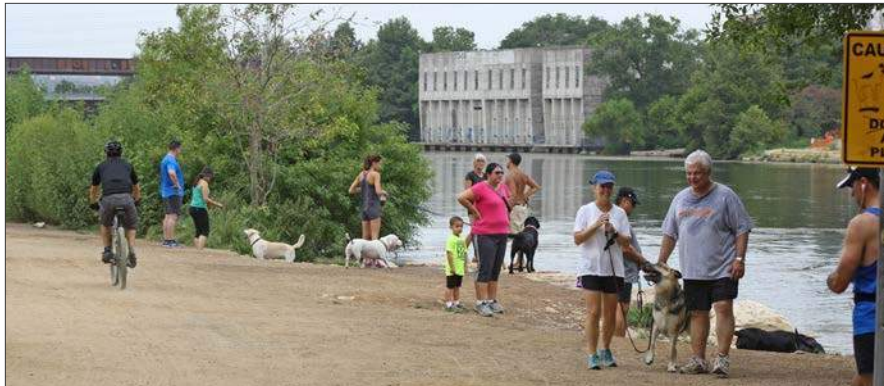
Figure 4.55 (Above): This popular water access point for dogs is badly trampled. Figure 4.56 (Middle): Poor trail drainage leads to visitors taking alternative routes, generally in the mulch around tree roots in the upper-left corner of this photo. Figure 4.57 (Below): Invasive species, erosion issues, and recommended restoration work in the Auditorium Shores Unit. Sources: COA, NAIP.

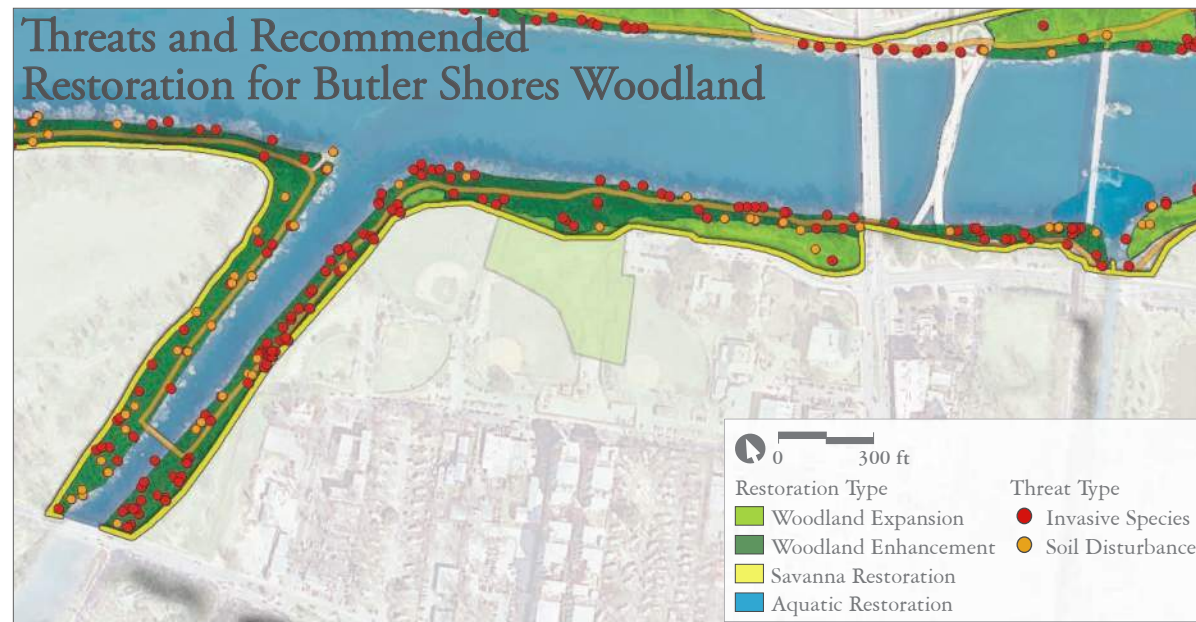
Figure 4.60: Invasive species, erosion issues, and recommended restoration work in Butler Shores Woodland Unit. Sources: COA, NAIP.

Management activities in this unit will be varied, addressing invasive species, erosion, and user experience issues. Erosion issues should be handled throughout the unit, with special attention to non-functional infrastructure. Conversion of underutilized portions of Butler Shores Park to woodland with supporting green infrastructure can alleviate numerous erosion problems within the unit while expanding the overall natural areas (Figure 4.62). Problematic invasive species not commonly found in other units need to be addressed, including Bradford Pear, bamboo, and paper mulberry.
