# The Butler Trail at Lady Bird Lake

## Urban Forestry and Natural Area Management Guidelines

The Trail  
Foundation

*Produced by Siglo Group, 2015*

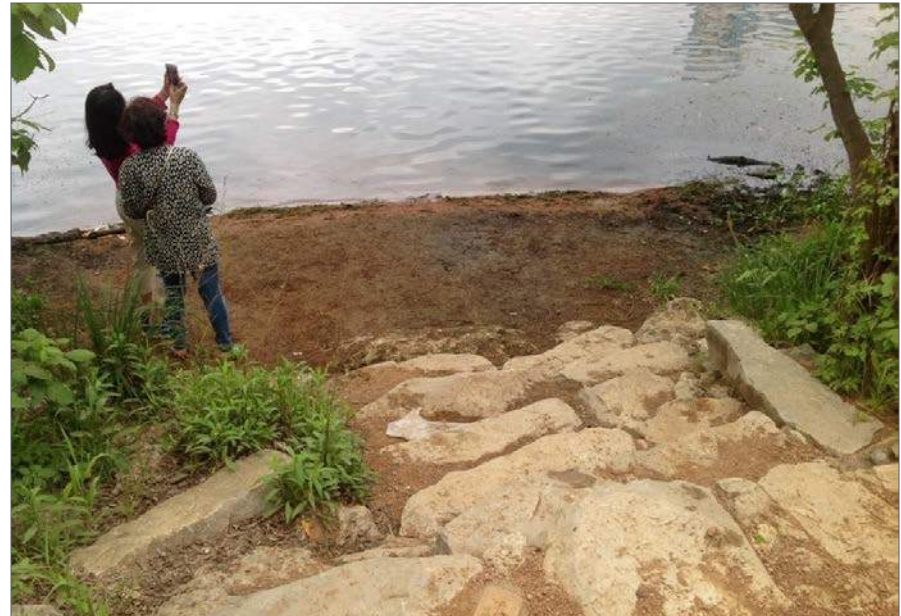
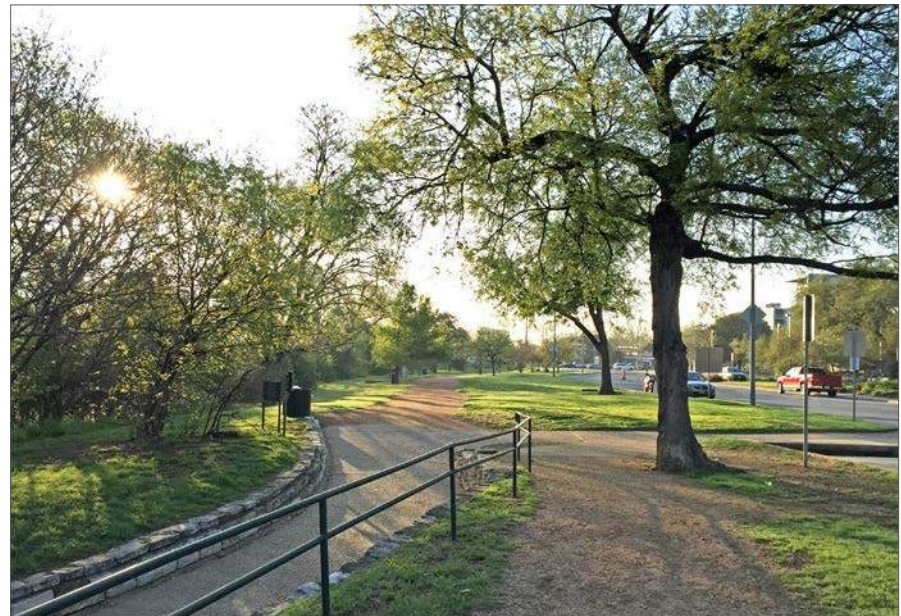
Figure 4.61 (Above): A well used formal water access point has stairs leading users to the shore, the surface below is heavily trampled and eroding into the Lake. Figure 4.62 (Below): The underutilized lawn near PARD offices is recommended for woodland expansion.

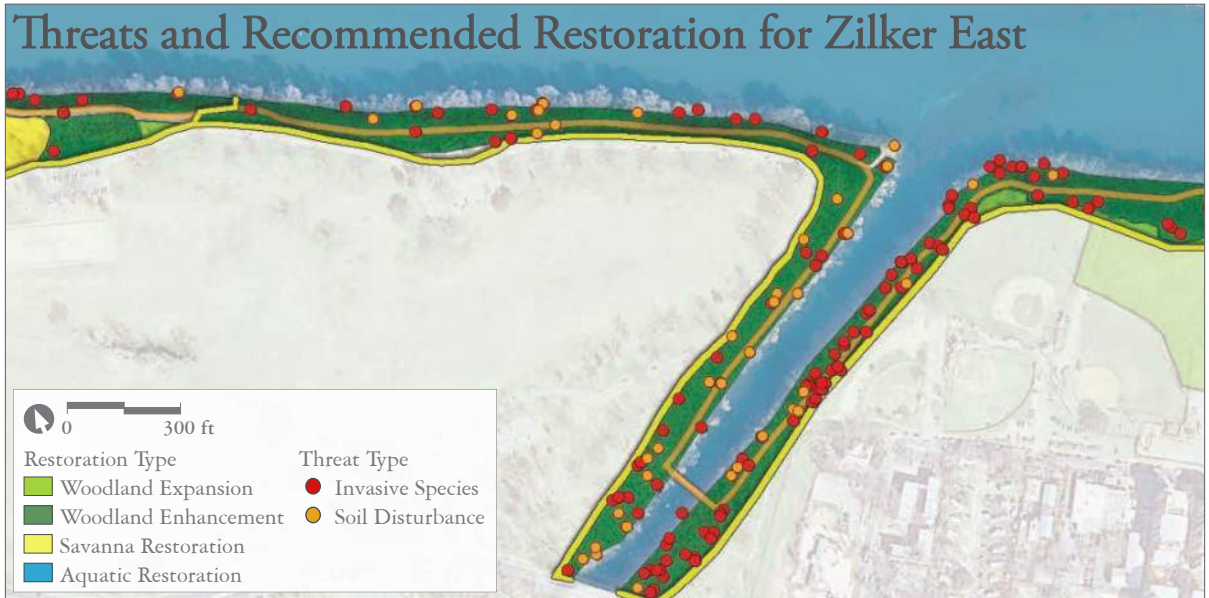
Figure 4.64 (Above, left): This bald cypress in Zilker East is one of the largest trees in the study area and in Austin. Figure 4.65 (Above, right): Young backberry trees dominate the woodland upland of the Trail along Barton Creek. Figure 4.66 (Below): Invasive species, erosion issues, and recommended restoration work in the Zilker East Unit. Sources: COA, NAIP.

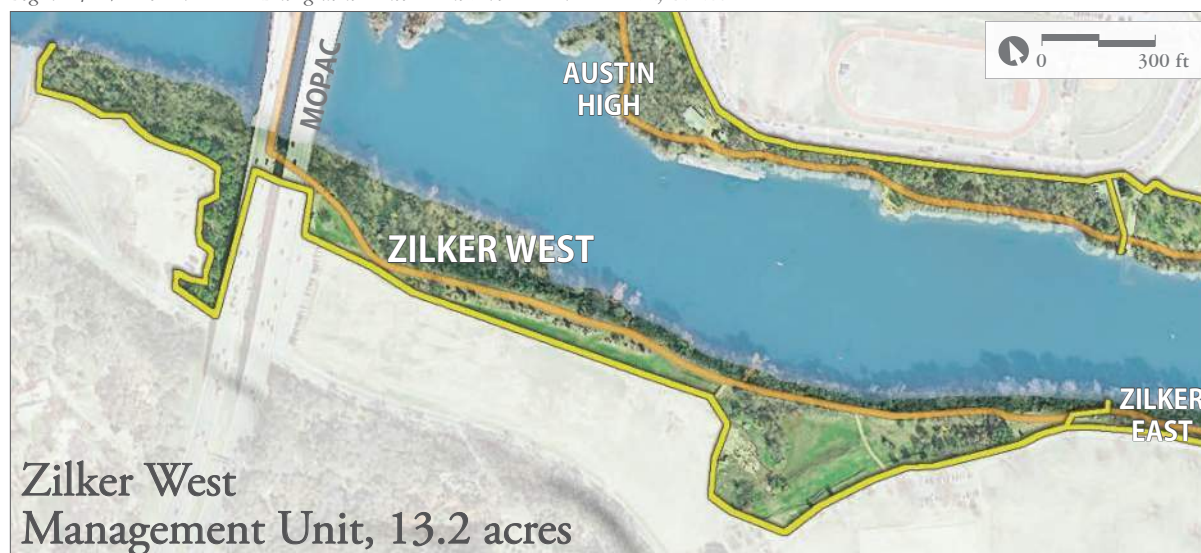
Figure 4.67: Zilker West Management Unit boundaries. Sources: COA, NAIP.

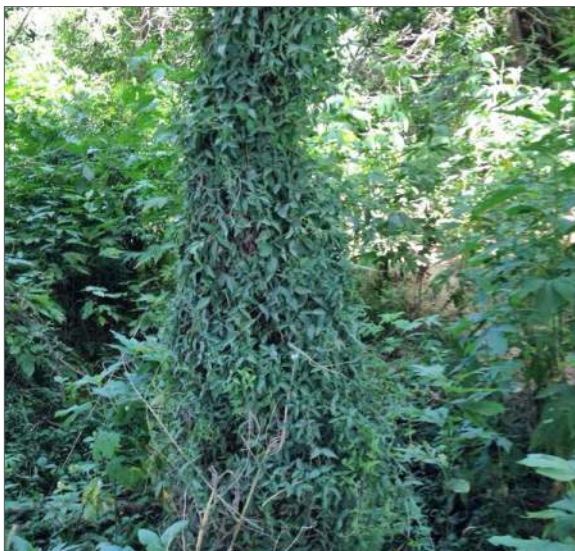
Figure 4.69: Invasive catclaw vine in Zilker West.

There are two catclaw patches, one just east and one just west of MoPac (Figure 4.69). Both are currently limited in area, but very dense. Two patches of sweet autumn clematis were found right along the Trail 850 ft east of MoPac. This species is abundant in many units but is not currently common in Zilker East or West. Silverberry, *Elaeagnus macrophylla*, was

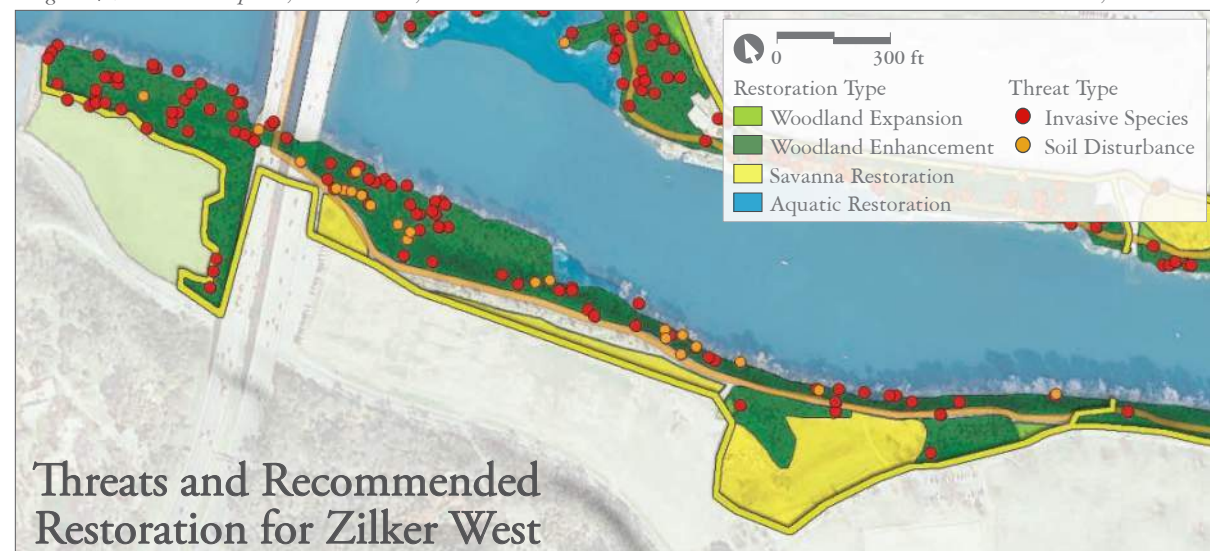
Figure 4.70: Invasive species, erosion issues, and recommended restoration work in the Zilker West Unit. Sources: COA, NAIP.

{E} Repair gully erosion east of MoPac. Where repair is not feasible, armor areas to minimize damage to surroundings. **High priority**

{I & R} Remove giant reed, Ligustrum, heavenly bamboo, and Chinaberry west of MoPac with additional treatment as necessary, planting, and seeding. **Medium priority**

{I} Remove Chinaberry at edge of existing woodlands. **Low priority**

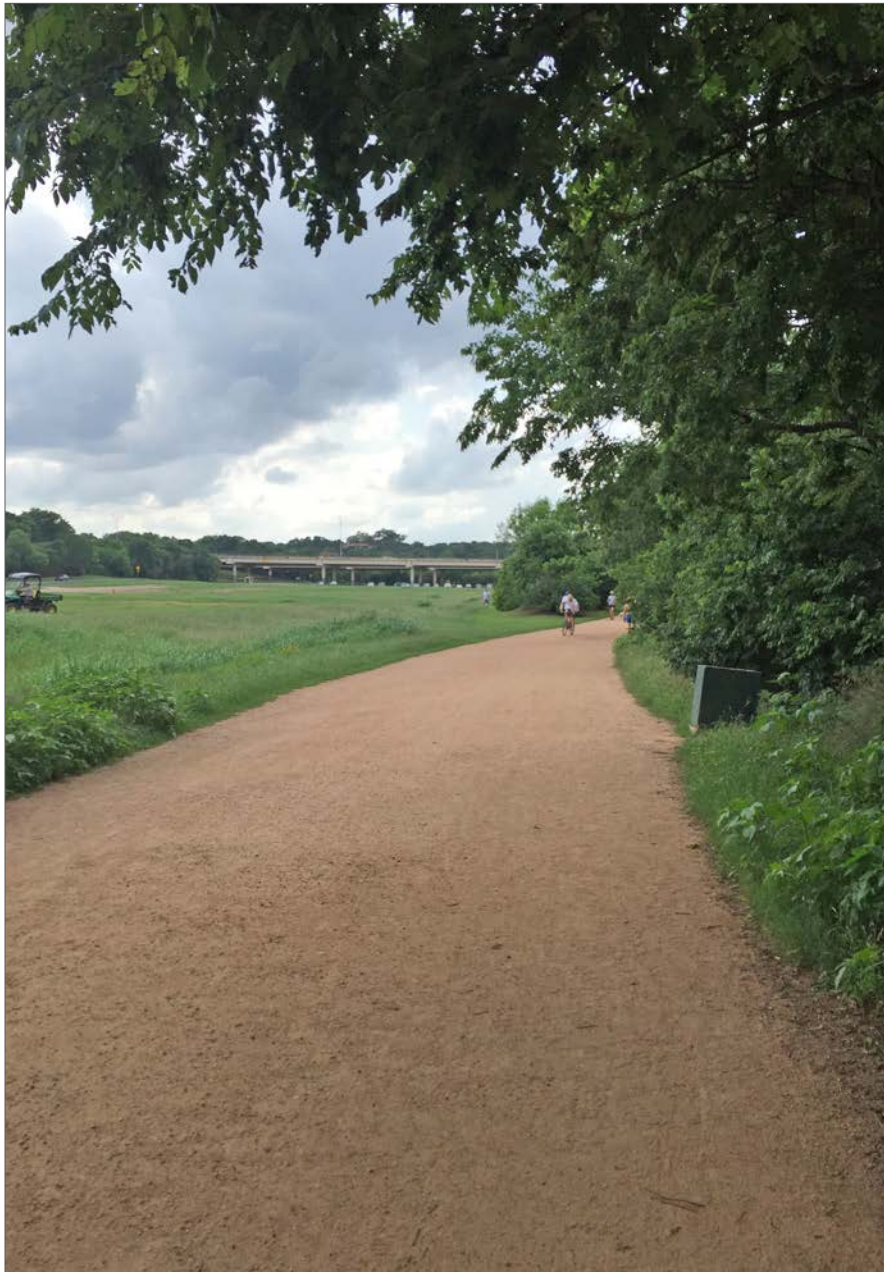
Figure 4.71: The wide Trail throughout much of Zilker West should be narrowed to allow more space between the Trail and the slope.
